WOOD DESTROYING ORGANISM

APR 02, 2020

WOOD-DESTROYING ORGANISMS INSPECTION REPORT

Structure(s) on Property Inspected Single Family Residence Only

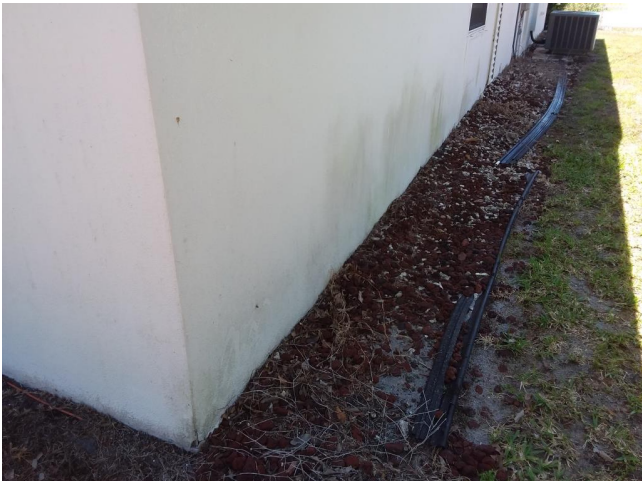
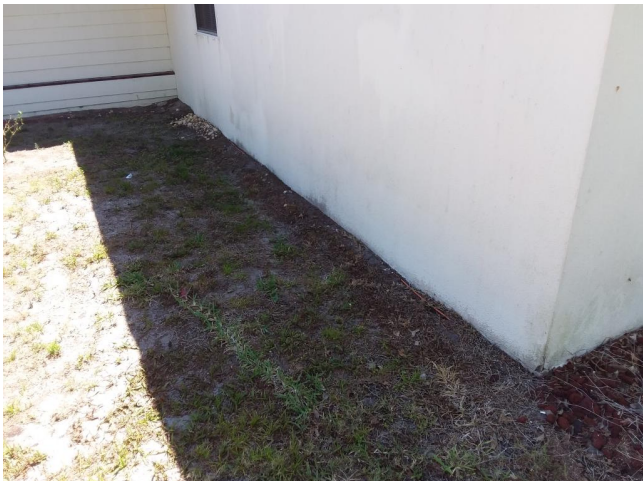
- Flower bed planters at front window.
- On-grade wood frame construction at enclosed garage and Northeast side of the house (bedroom & office).
- Roof leaking into rear porch bathroom.

Conductive conditions NE

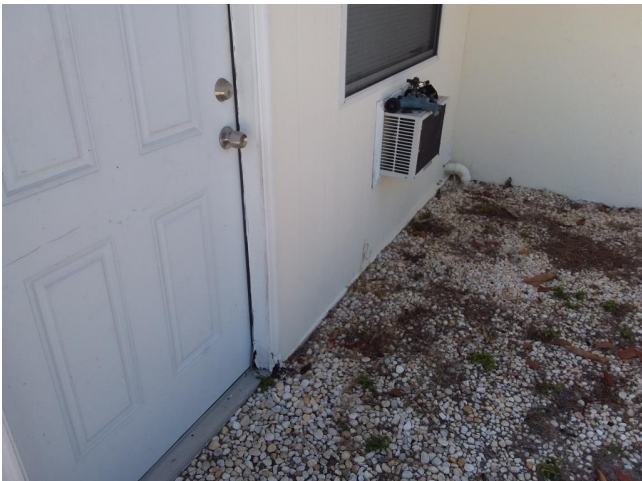
Conductive conditions (garage)

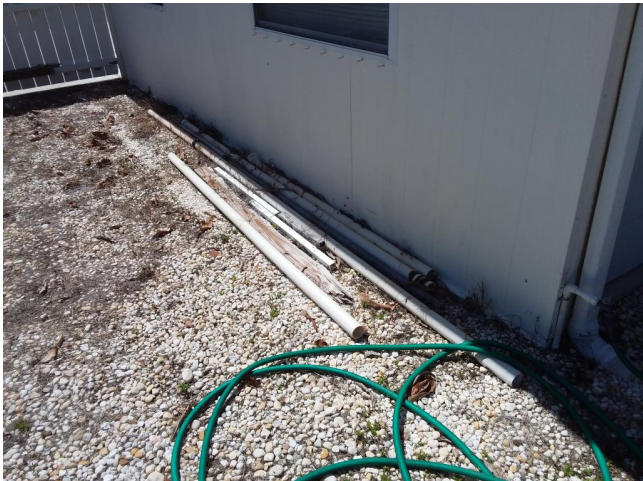
Conducive conditions (garage)

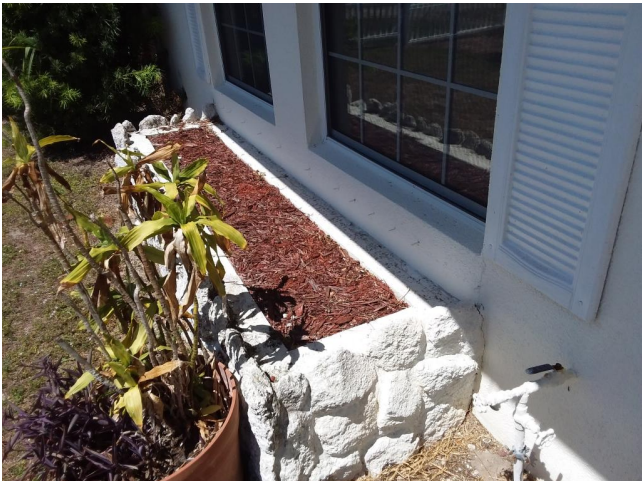
Conducive conditions (planter)

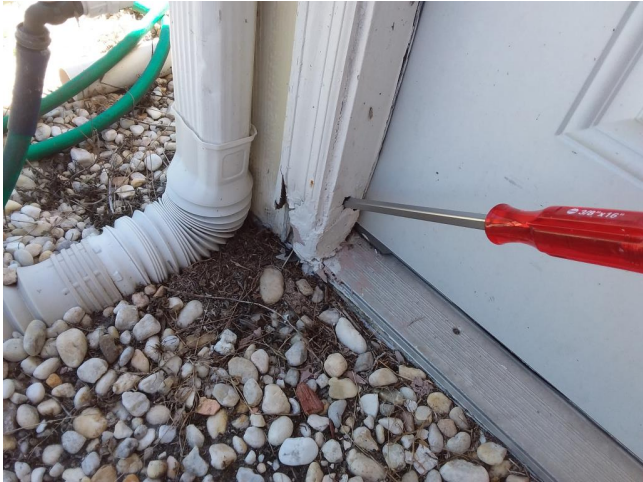
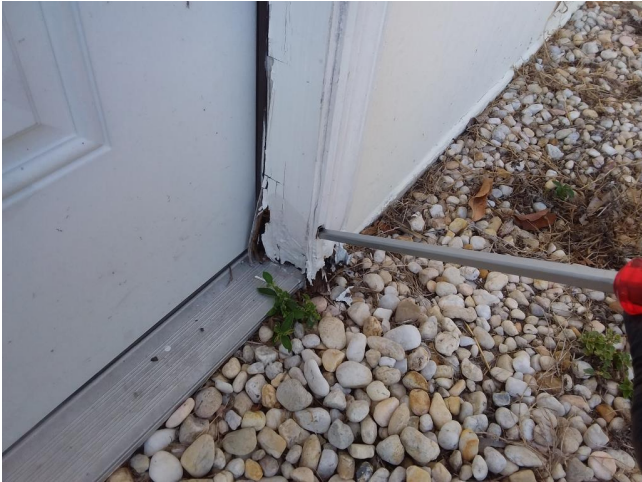
- Bottom of the front door, it's door frame and trim.
- Garage base boards and trim throughout; bottom of the service door frame; Bottom of the garage door frame and trim.
- Porch bathroom wall ceiling and around it's window frame.

Wood decay (garage service door)

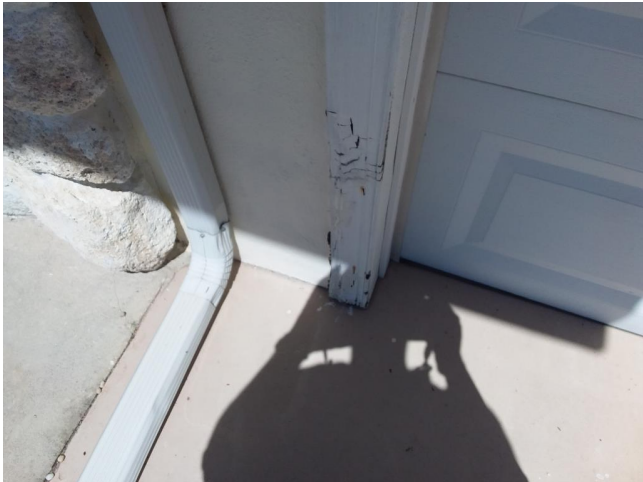
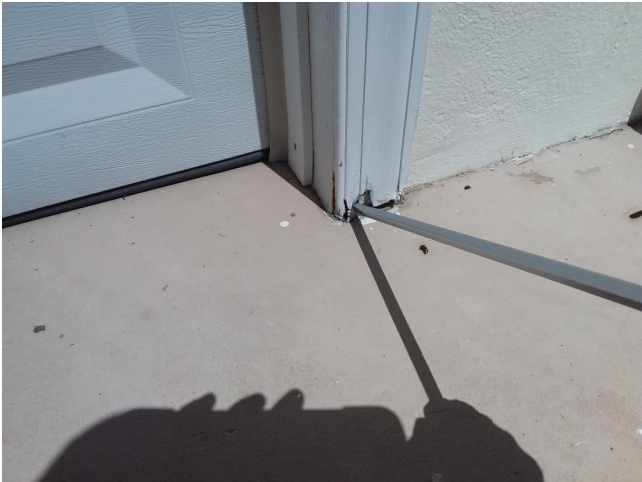
Wood decay (garage door)

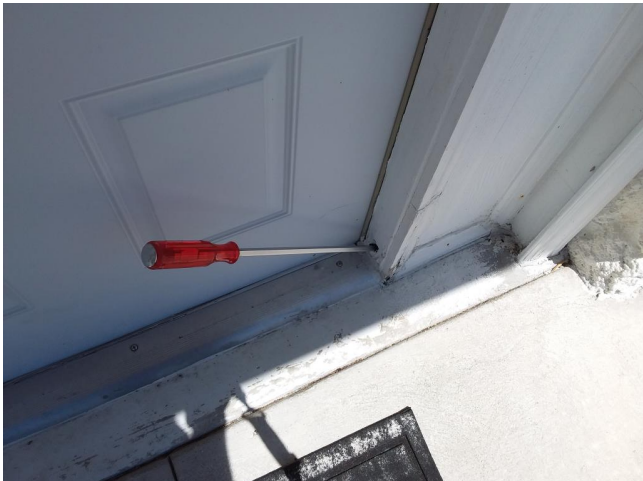
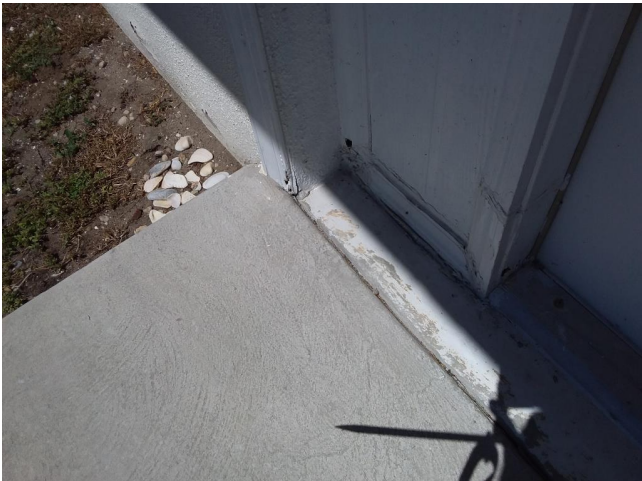
Wood decay (front door)

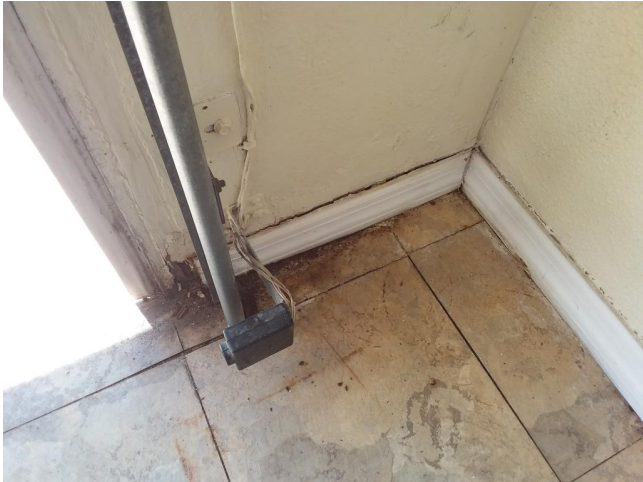
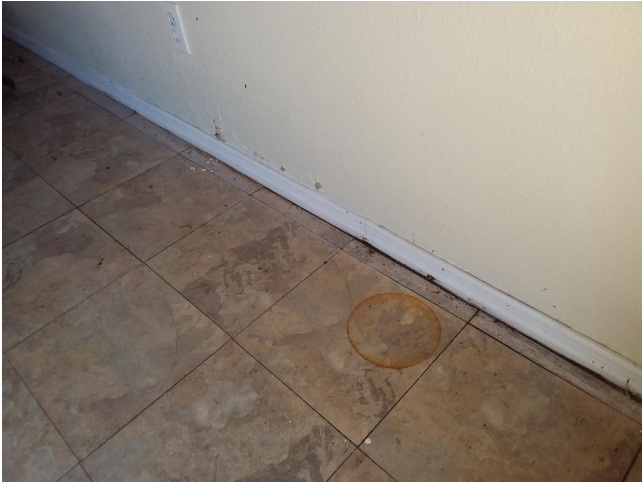
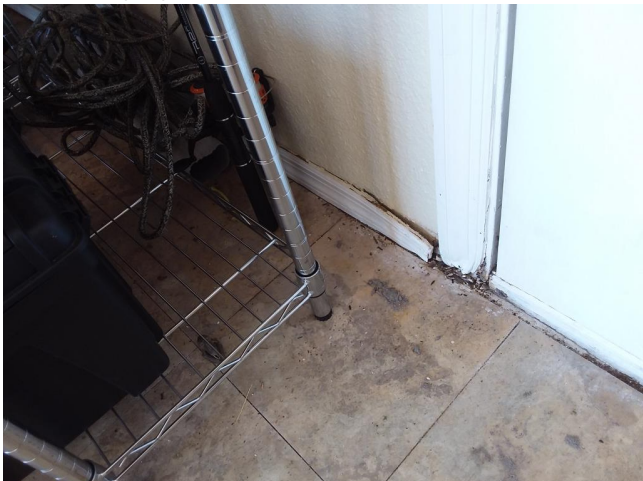
Wood decay (garage base boards)

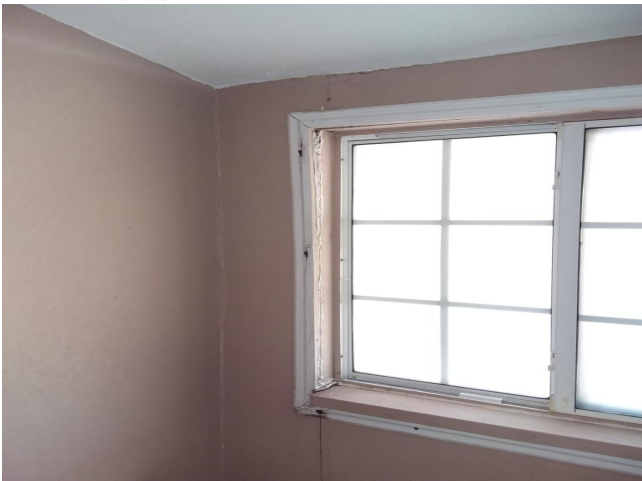
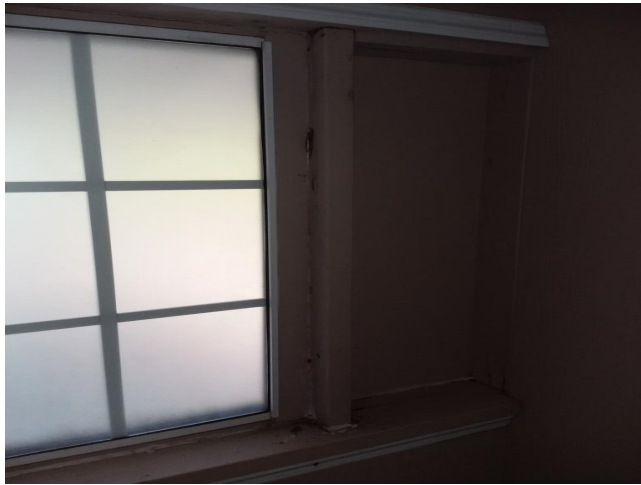
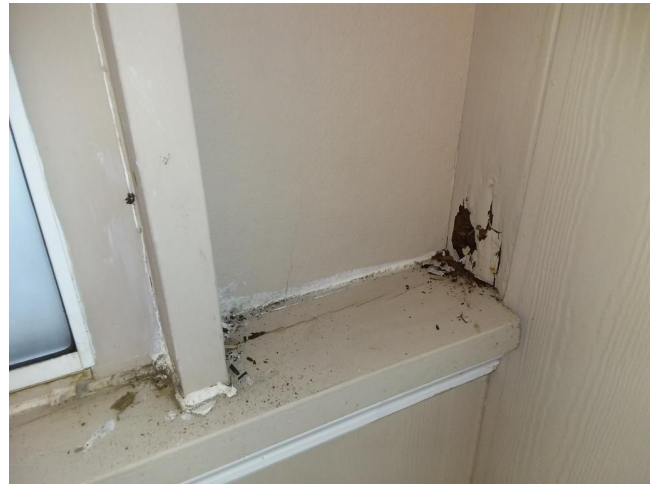
Wood decay (porch bath window)
