Engineer's Foundation Evaluation

On 3/30/2026 a foundation evaluation was performed at the property located at address 1234 Main Street San Antonio, FL, 33576, which consists of a 2605 square-foot single family attached structure built in 2025 (1 years old) with a slab on grade foundation.

ENGINEER'S FOUNDATION EVALUATION

San Antonio, FL 33576

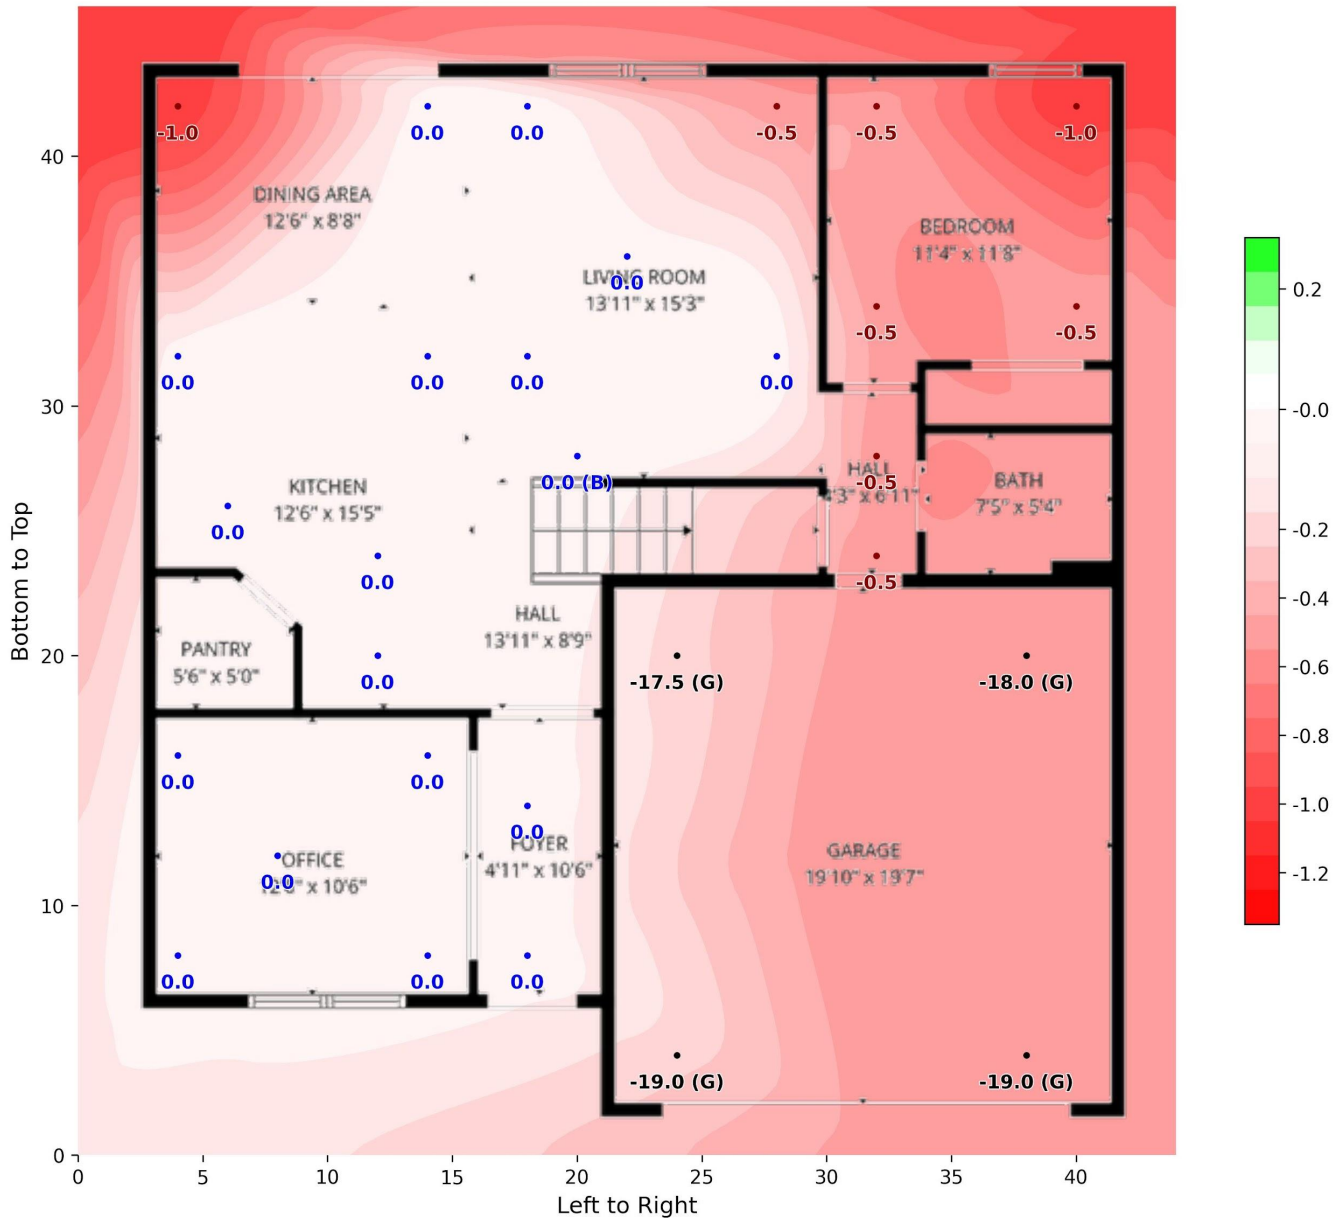
Elevation Plot Graphic (Figure A)

The elevation plot resulted in the graphic as depicted above in Figure A. The red-points and areas are elevation measurements that were lower than the base station elevation (0.0). The green-points and areas are elevation measurements that were higher than the base station elevation (0.0). The blue-points (and white areas) are equal to the base station elevation (0.0). The base station is depicted with a (B) symbol. The elevation plot takes into account differences in flooring thicknesses. The maximum elevation point was determined to be 0 inches and the minimum was -1 inches, resulting in an elevation difference of 1 inches of difference across the structure.

Elevation differences across the structure are the first indicator that a foundation problem may or may-not exist. As documented above, the maximum elevation point of this structure was determined to be 0 inches and the minimum was -1 inches, resulting in an elevation difference of 1 inches of difference across the structure. The elevation plot takes into account differences in flooring thicknesses. The elevation deflection across an entire structure should, best-case-scenario, remain within 0.5 to 1-inch depending on the age of the structure. Measured differences approaching 2-inches are an initial sign of possible foundation fatigue. The maximum allowable elevation difference is subjective, depending on other factors such as the visual condition, size, and age of the structure (1 year(s) old) along with how the foundation performs when calculating deflection and tilt.

Based on observed elevations of the foundation from the elevation plot, the elevation differences fall within industry standards and tolerable limits. Note: elevation measurements alone is not the only indicator of foundation problems; see the deflection and tilt calculations (and the report's overall conclusion) for a complete understanding of foundation stabilization.

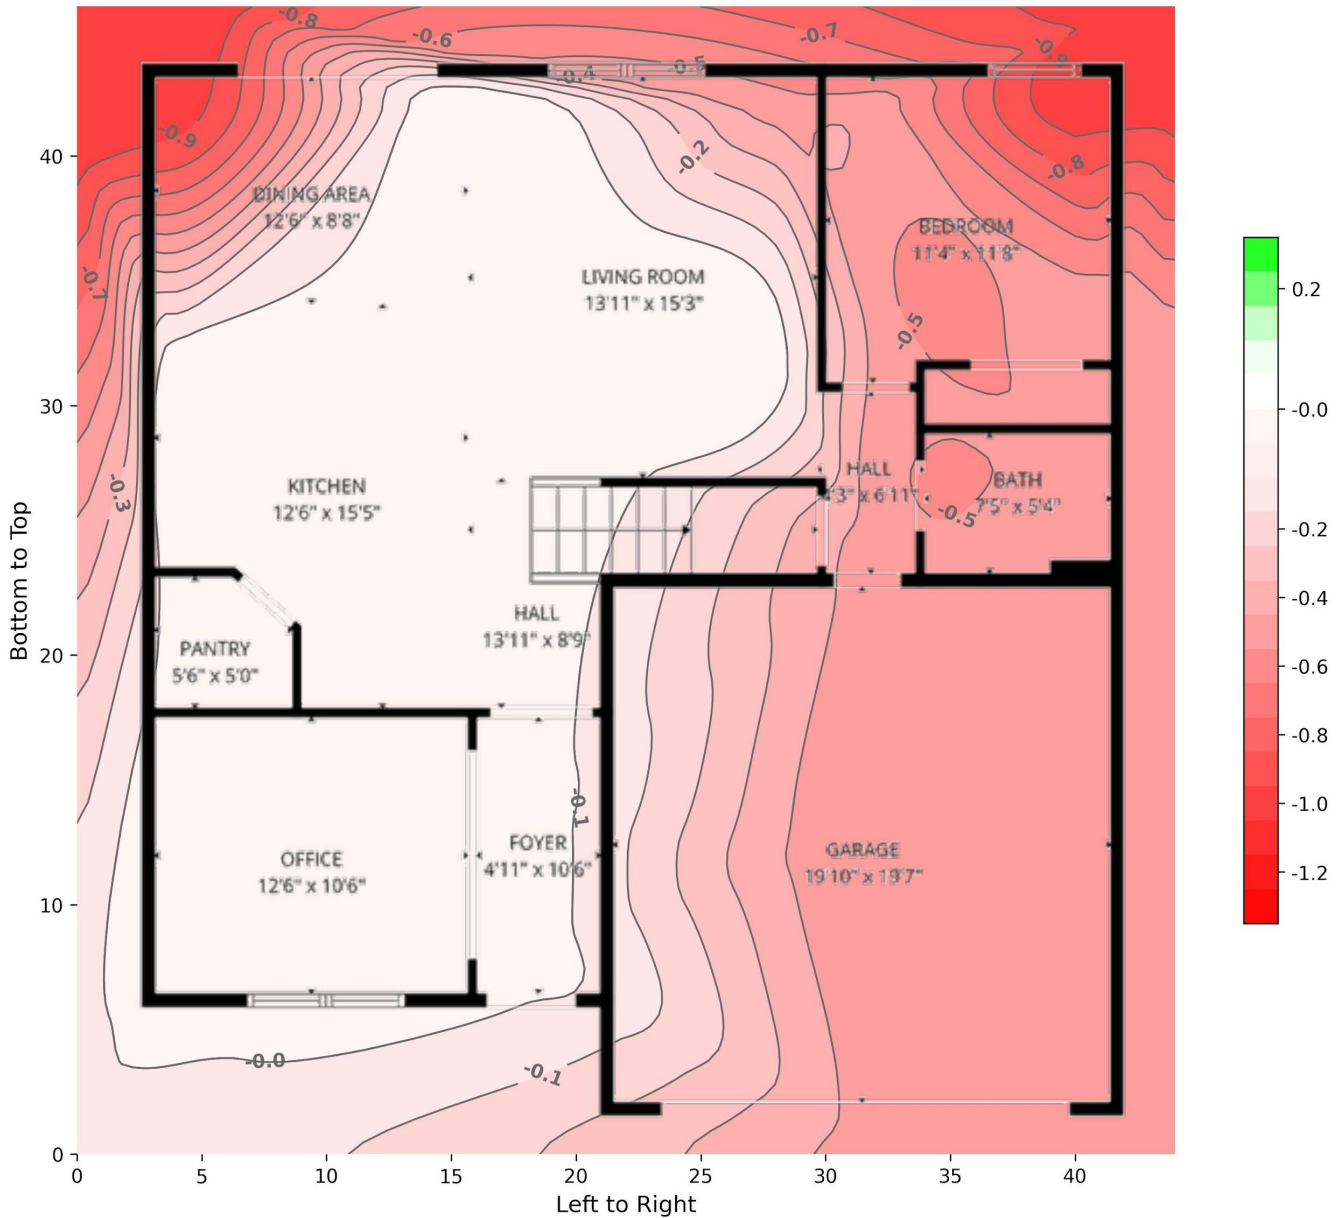
Mesh Contour Graphic (Figure B)

The mesh contours graphic depicted above in Figure B is similar to the elevation plot. The red, green, and white areas depict areas that are lower, higher, and equal to the base station elevation (0.0). The lines or contours (similar to map topography) are labeled at specific intervals.

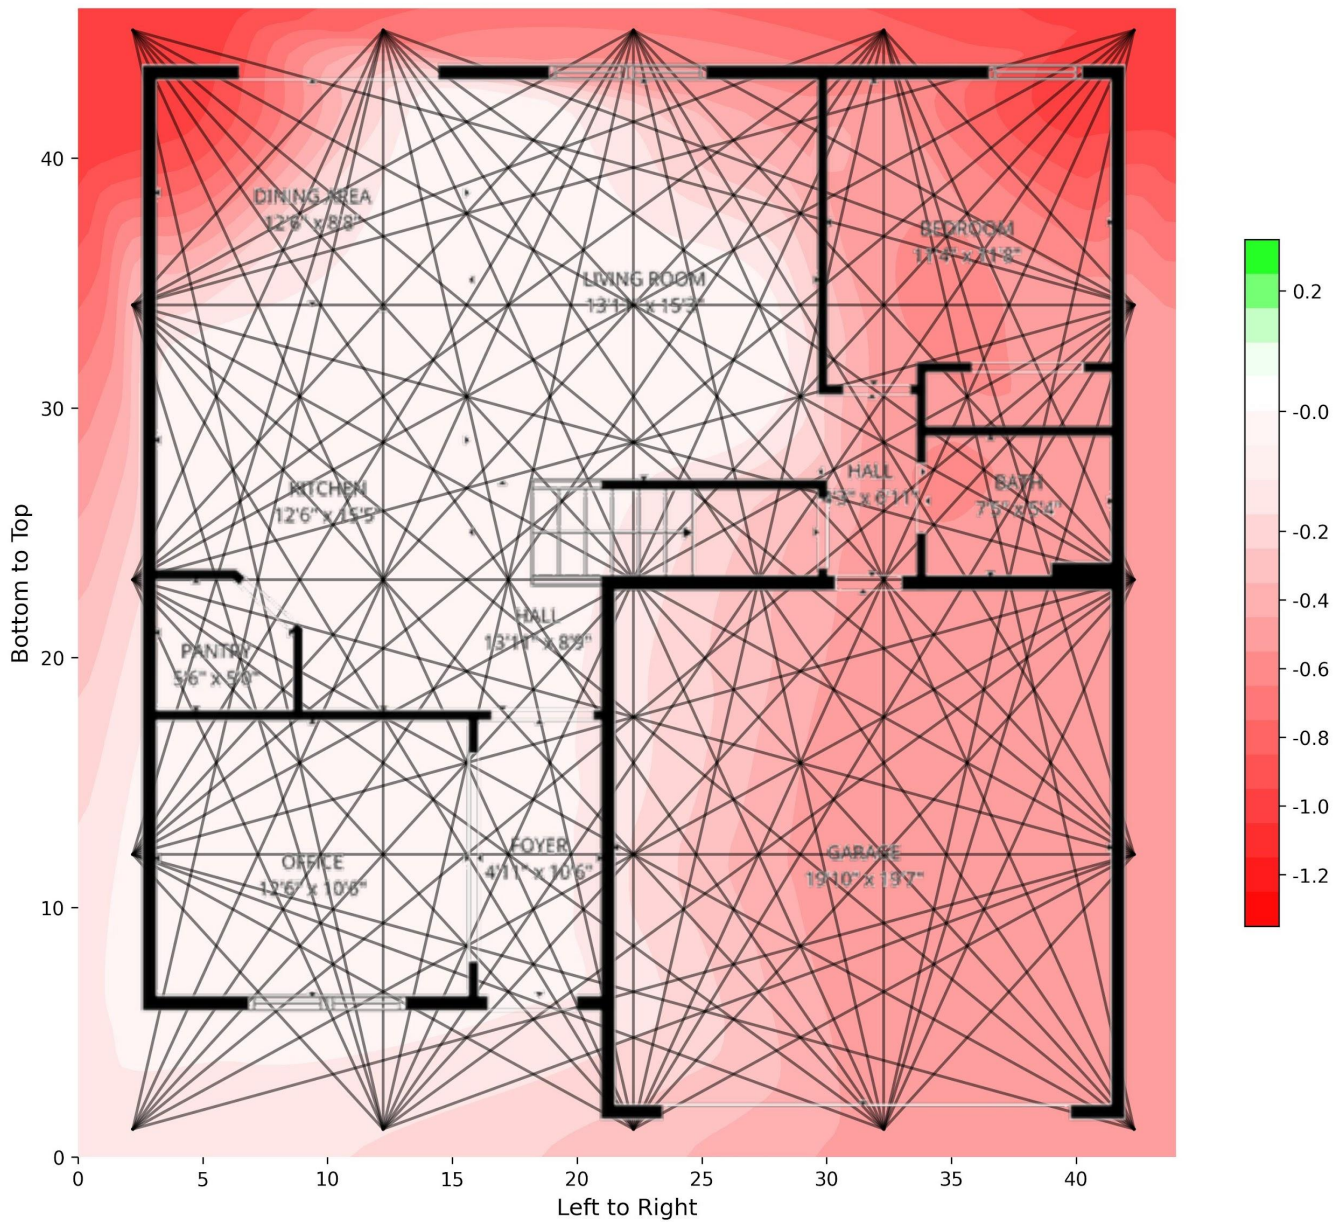
All Profiles Graphic (Figure C)

Deflection failures can be considered localized failures of the foundation in (sometimes) isolated portions of the foundation. Of the 75 deflection profiles calculated, 0 failures were identified.

As no deflection failures are present, these findings indicate that the foundation is not experiencing localized failures that would indicate specific areas of the foundation that are failing. Note: deflection failures alone are not the only indicator of foundation problems; see the elevation and tilt calculations (and the report's overall conclusion) for a complete understanding of foundation stabilization.

Tilt failures can be considered structure-wide failures of the foundation. Of the 75 tilt profiles calculated, 0 failures were identified. The tilt calculations resulted in a maximum tilt profile of 0.18%.

As no tilt failures are present, these findings indicate foundation settling that is within tolerable limits. Note: tilt failures alone are not the only indicator of foundation problems; see the deflection and elevation calculations (and the report's overall conclusion) for a complete understanding of foundation stabilization.
