SAFELINE HOME INSPECTIONS LLC

## PRE-DRYWALL INSPECTION COPY

1234 Main Street  
Brandon, FL 33511

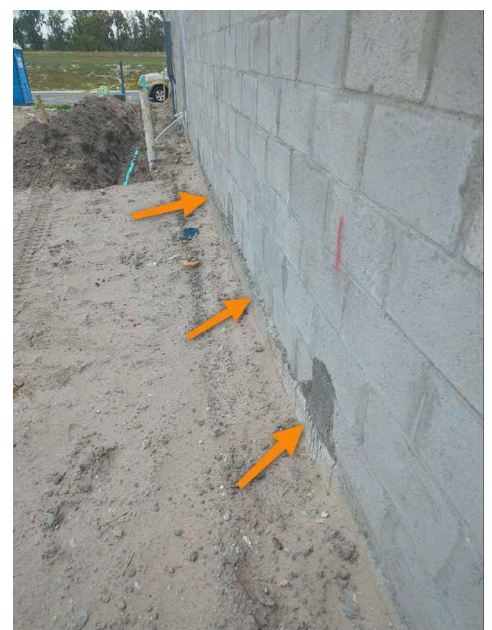
### 3.7.1 Foundation

#### **CHIP AWAY EXCESS FOUNDATION**

Observed excess slab in several areas around the side of the house. This excess slab is causing the stucco wall to appear uneven and not plumb. To ensure the stucco wall's appearance and integrity, it is recommended to remove the excess slab from these areas.

Contact your builder.

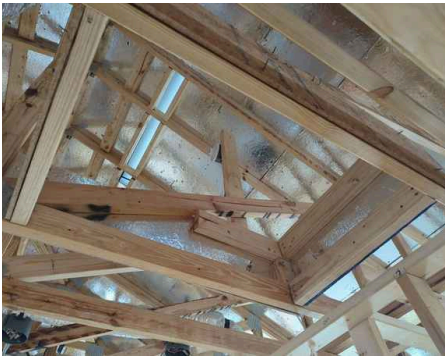
The attic access was inspected to insure that it was built to comply to the current minium standards. There was proper clearance, and the attic access light was withing reach of the access panel.

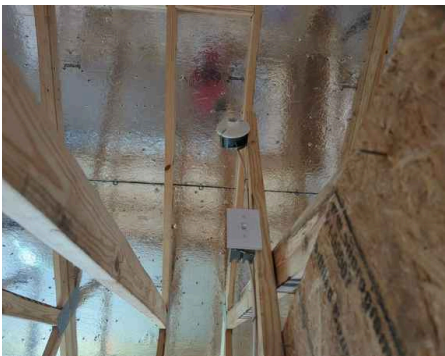
The attic access light was observed within an arms reach of the attic access panel.

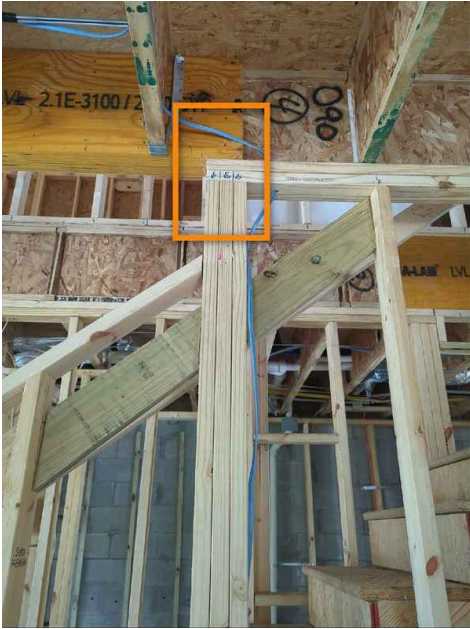
#1 - Family Room

**MISSING UPLIFT CONNECTOR AT BEAM-TO-WALL CONNECTION**

No visible uplift connector was observed at the beam-to-wall connection in the area inspected. This condition may reduce the structure's ability to resist uplift and lateral forces, which is especially important in high-wind events and for compliance with the approved structural design. Because these connectors are critical structural components and may have been omitted, concealed, or improperly installed, this connection should be verified against the approved structural plans. A qualified licensed contractor should evaluate the condition and install any missing connector hardware as required.

Contact a qualified professional.

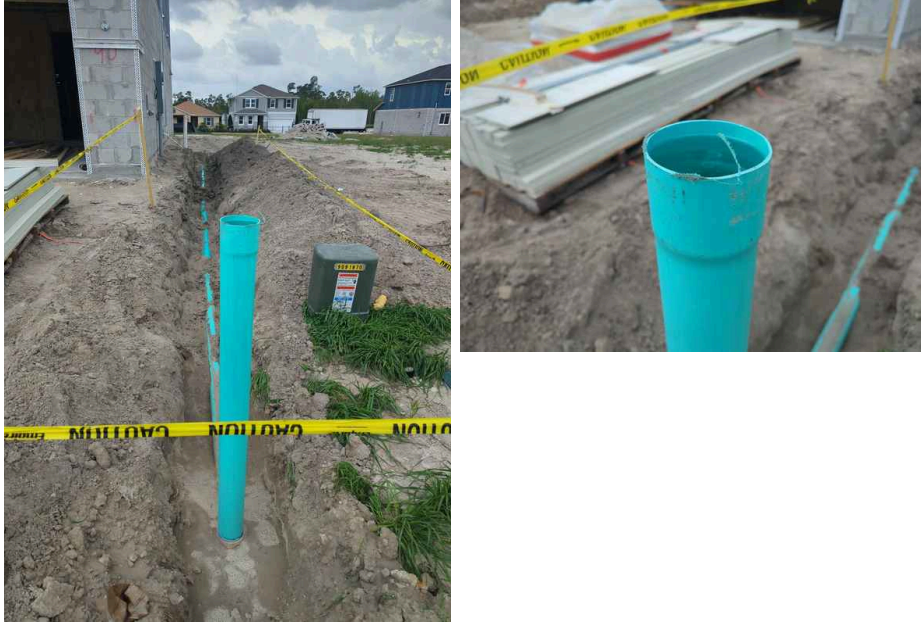
The Plumbing Clean Out was visible and capped at the time of inspection. This is for your information.

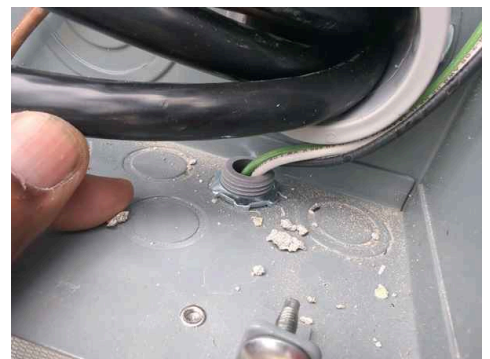
#1 - main panel

#### MISSING WIRE BUSHING

A wire bushing is missing where electrical wires pass through the breaker panel. Wire bushings protect conductors from sharp edges and abrasion, preventing damage to wire insulation. The missing bushing creates a risk of wire damage and potential electrical hazards. An electrical contractor should inspect the panel and install the appropriate bushing to ensure proper protection and safe operation.

Contact a qualified professional.

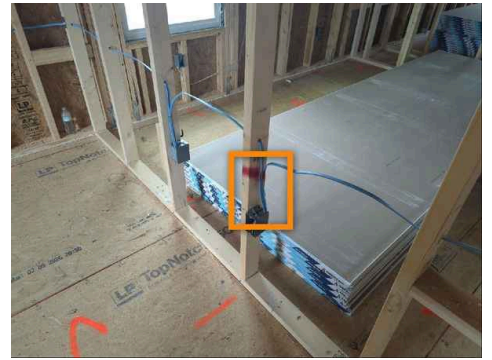
#1 - Bedroom

**LOOSE WIRING**

Observed that one or more areas of wiring were not correctly secured to the studs. Proper securing of wiring is crucial to prevent potential damage, electrical hazards, and ensure compliance with safety standards.

Contact a qualified professional.

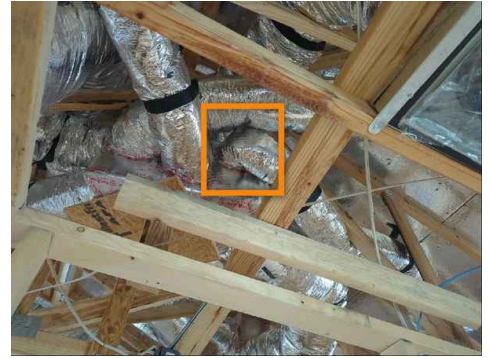
#1 - Upstairs Hallway

#### **EXCESSIVE DUCT BEND**

A 90+ degree bend was observed in the ductwork during inspection. Ductwork with sharp bends restricts airflow, reducing heating and cooling system efficiency and forcing the HVAC system to work harder to distribute conditioned air. The ductwork should be reconfigured to eliminate or minimize sharp bends, ideally using gradual curves or additional duct sections to redirect airflow smoothly.

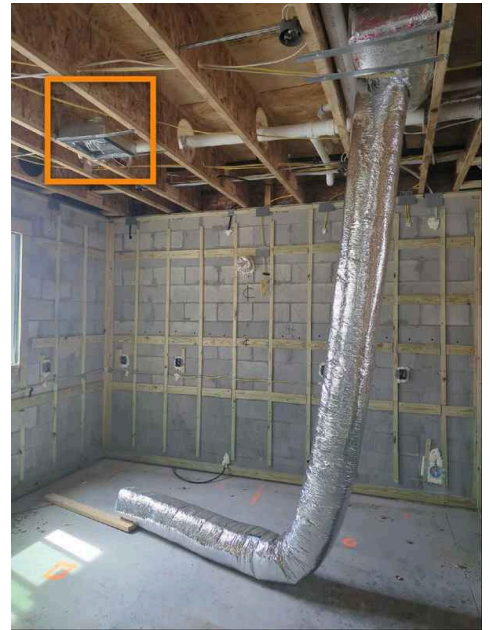
#1 - Kitchen

#### **MISSING SUPPLY DUCT**

Contact your builder.
