SAFELINE HOME INSPECTIONS LLC

## FULL HOME INSPECTION REPORT COPY

1234 Main Street  
Brandon, FL 33511

04/29/2026 9:00AM

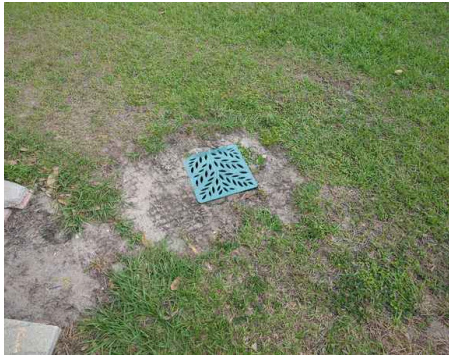
### **Vegetation, Surface Drainage & Grading: In-Ground Drainage System Present**

An in-ground drainage system was observed on the property during the inspection. These subsurface systems are designed to manage water runoff by collecting and directing excess water away from the structure through underground piping or channels. Proper drainage helps reduce the potential for standing water, soil saturation, and moisture intrusion around the foundation. The system should be maintained and monitored to ensure it remains clear of debris and continues to function as intended.

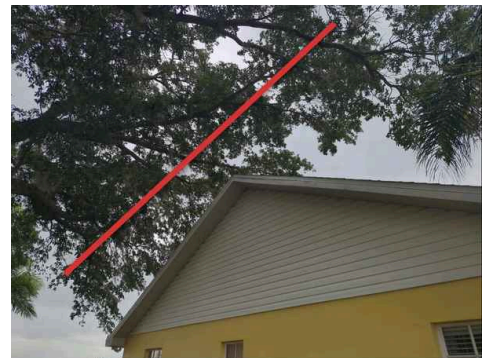
One or more tree limbs extend above the roof. This condition can potentially damage the roof and impede proper drainage, and may also be a concern for home insurance providers. A qualified tree service company should be consulted to trim the overhanging limbs to protect the roof and ensure compliance with home insurance requirements.

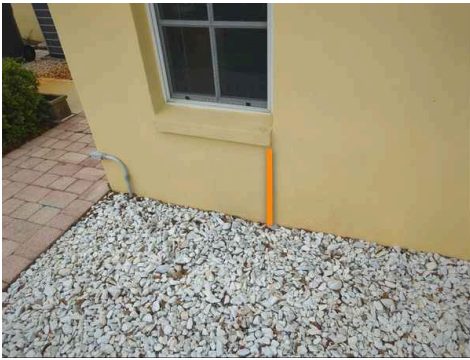
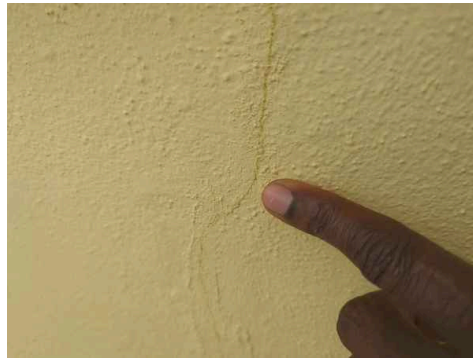
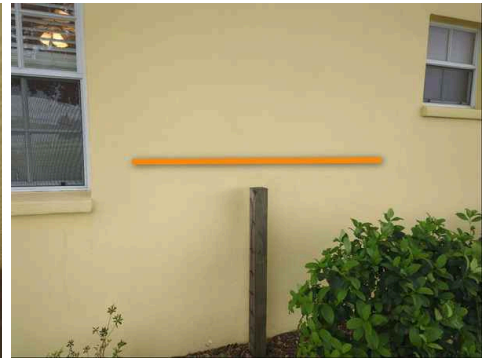
Hairline cracks were observed in the exterior stucco siding. These cracks, though small, can allow moisture intrusion over time, potentially leading to deterioration of the underlying materials and reduced energy efficiency. Continued exposure to moisture may also cause the cracks to expand, compromising the weatherproofing of the home's exterior. It is recommended to have these cracks evaluated and sealed by a qualified contractor to prevent further damage and maintain the integrity of the exterior envelope. Regular monitoring and maintenance of stucco surfaces are essential for long-term durability.

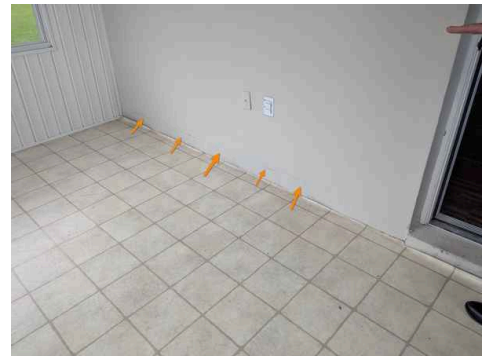
SUITE SUNROOM

A horizontal crack was observed along the lower portion of the exterior wall inside the sunroom near the floor line. Cracks in this location may develop due to minor settlement, movement of building materials, or stress along the wall base where the wall meets the slab or framing components. While the crack appears relatively minor at the time of inspection, openings in wall surfaces can allow moisture intrusion, contribute to further deterioration, or indicate potential movement of the structure over time. It is recommended that the crack be sealed and repaired by a qualified contractor and that the area be monitored for any signs of continued movement or expansion.

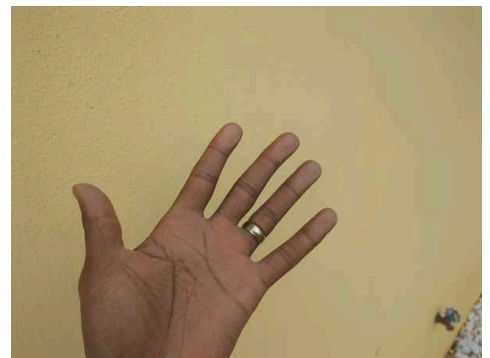
The exterior paint is showing signs of wear, fading, or chipping, which reduces both its appearance and ability to protect the home from weather damage. A licensed painting contractor should evaluate the condition to determine if spot repairs or a full repaint are needed. If the home hasn't been painted in the last 10 years, a full repaint may be advisable to restore curb appeal and maintain the integrity of the exterior surfaces.

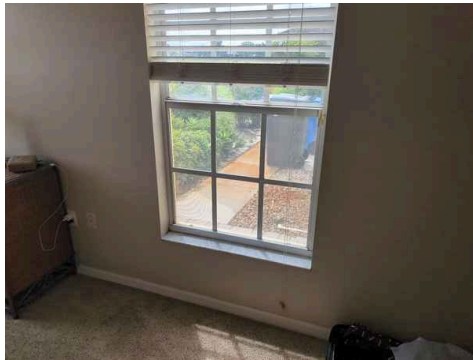
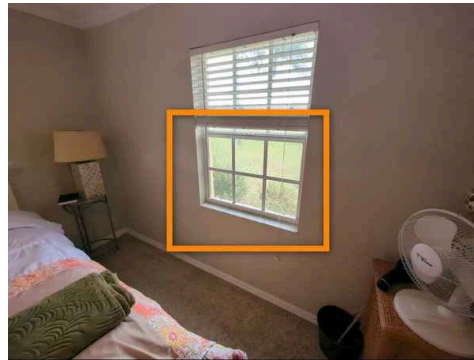
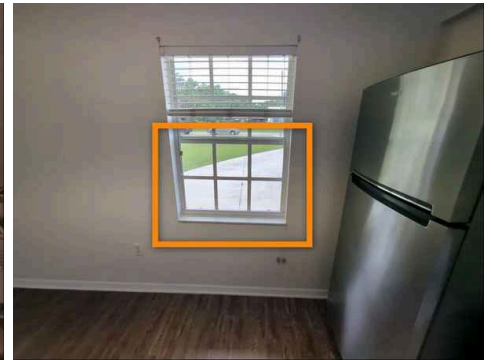
**WINDOW WILL NOT STAY OPEN DUE TO BROKEN SPRING**

One or more windows were found to have broken or failed sash springs, resulting in the inability of the window to remain open on its own. This presents a potential safety hazard, particularly if the window unexpectedly closes, and also limits proper ventilation. It is recommended that a qualified window repair technician replace the defective springs to restore full functionality and safety.

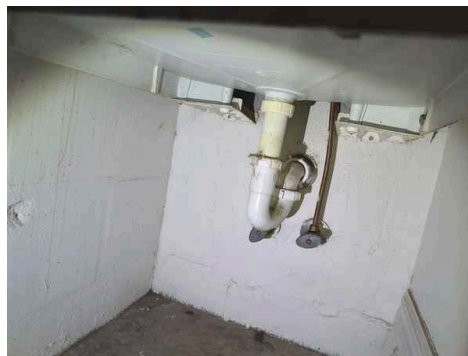
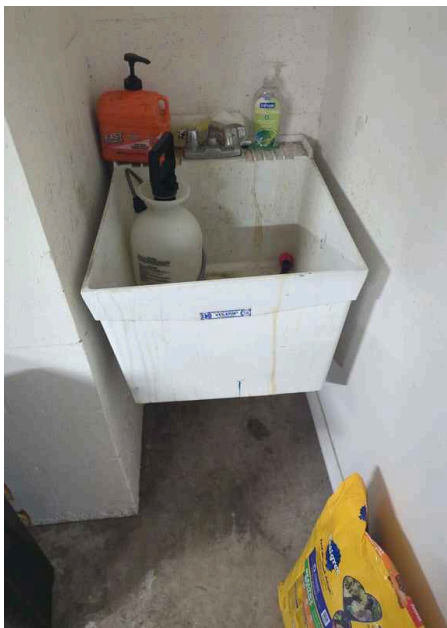
**Wash Basin: Required Pictures**

Found that there were no leaks at the wash Basin faucet or drain piping. No other deficiencies were present.

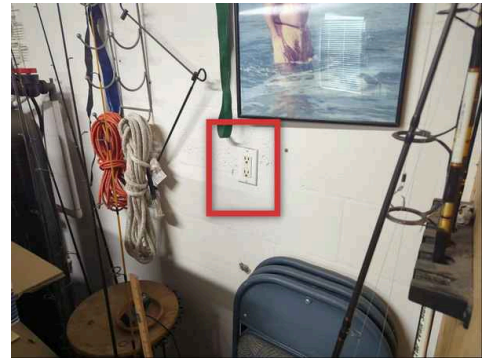
#1

The GFCI outlet located in the garage was found to be faulty and did not respond properly to testing. Ground Fault Circuit Interrupter (GFCI) outlets are critical for safety, as they help protect against electrical shock in areas prone to moisture. A malfunctioning GFCI outlet compromises this protection and should be addressed promptly. It is recommended to have the outlet replaced or repaired by a licensed electrician to ensure safe and reliable operation.

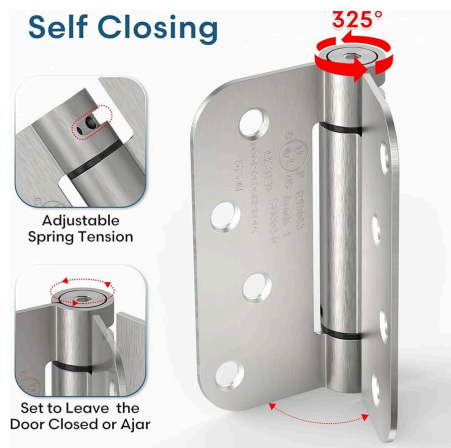
There is no self-closing device on the door from the house leading to the garage. It is strongly recommended that one be installed in order to protect the residence against garage originated fires.

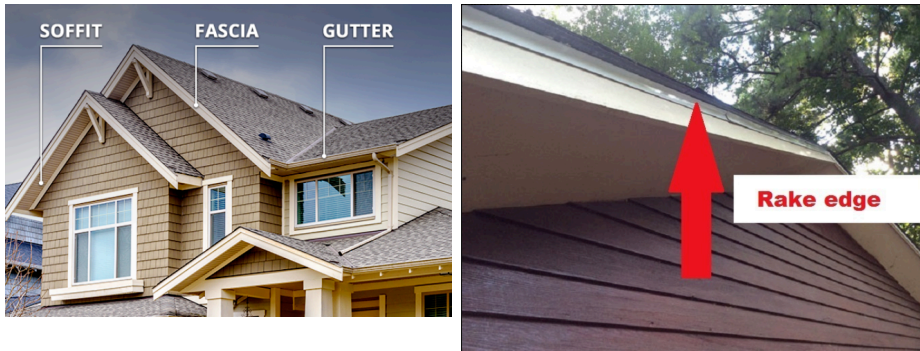
### Eaves, Soffits, & Fascia: Condition Satisfactory

Inspected for the installation of drip edge flashing at fascias (above the gutters) and at the gable rake trim (the diagonal edges of the roof). The flashing helps the surface water on the roof to discharge into the gutter. Flashing also helps to prevent water intrusion under the roof covering.

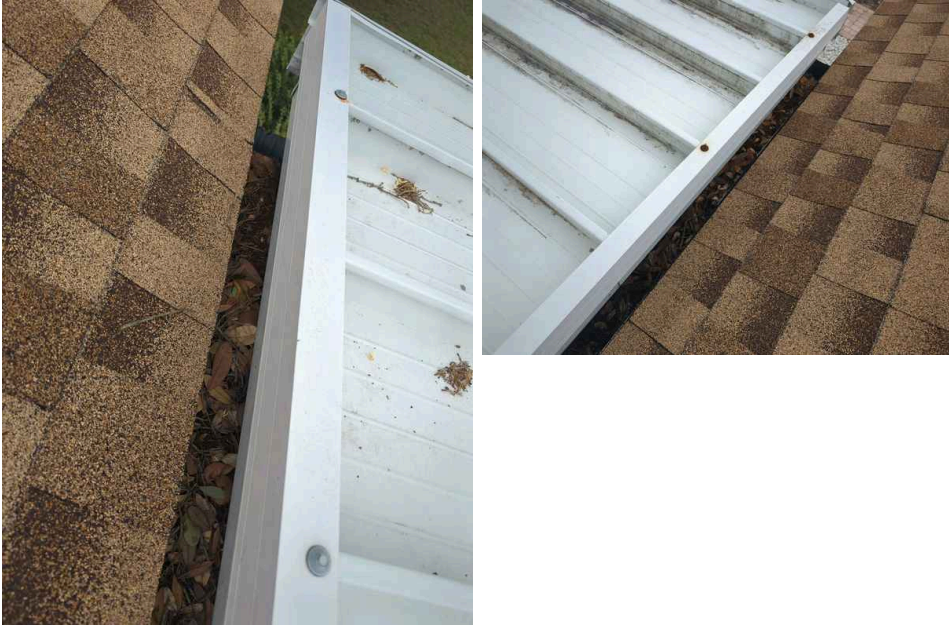
The gutters are clogged with debris and require cleaning to function properly. Accumulated leaves, dirt, and other materials prevent water from flowing freely through the gutter system. Regular cleaning ensures water is directed away from the foundation and prevents potential water damage, pest issues, and gutter deterioration.

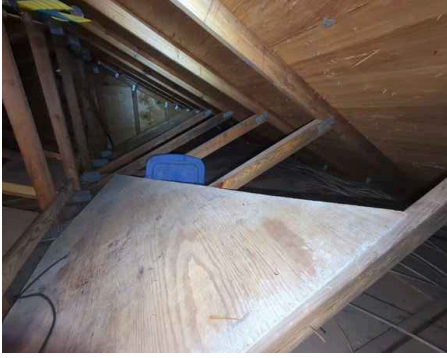
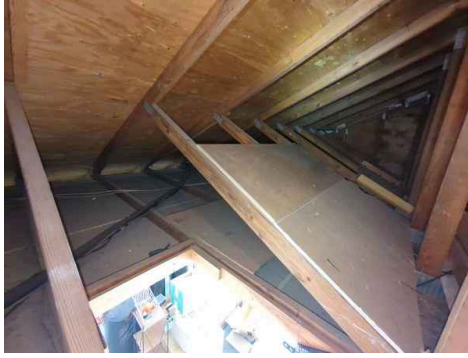
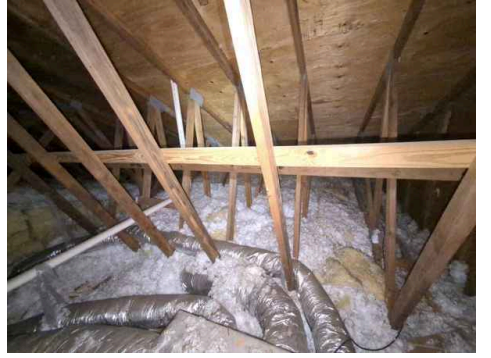
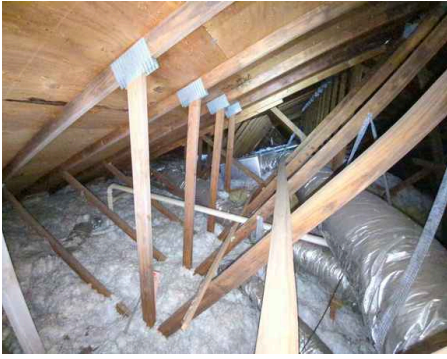
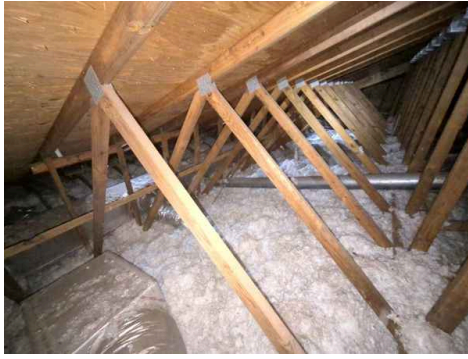
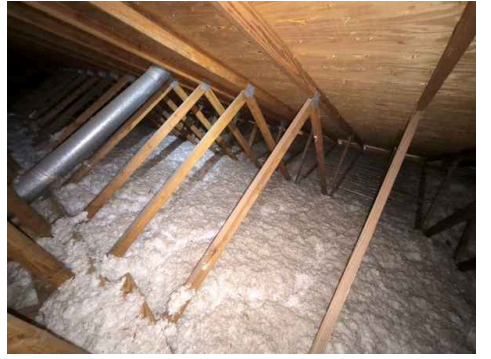
Structure: Required Pictures

The attic was inspected for signs of condensation, moisture, active leaks, or damaged trusses. Structural components were inspected from the attic space according to the InterNACHI Standards of Practice. No discrepancies were observed at the time of the inspection.

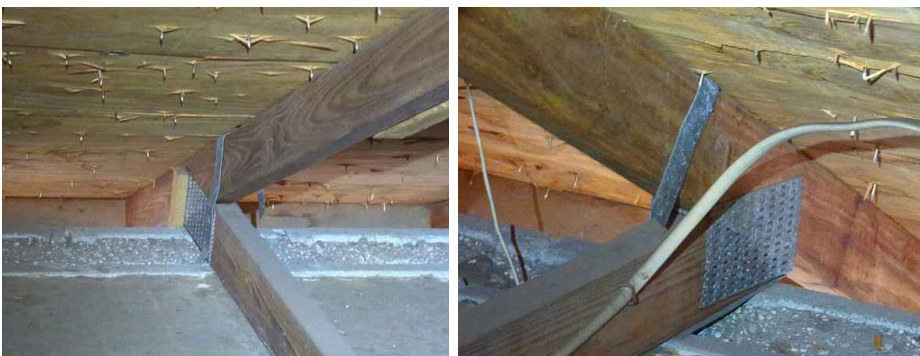
**Structure: Roof to Wall Connection Type**

Metal Strap 3+ Nails, Metal Clips 3+ Nails

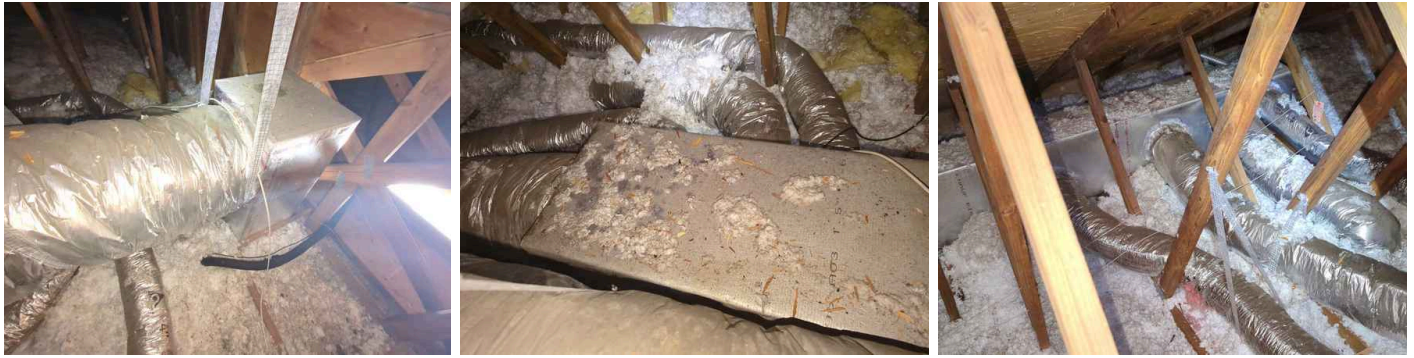
## Ductwork: Required Pictures

During the inspection, the visible duct systems, chases, and vents were thoroughly examined, following the InterNACHI Standards of Practice and local codes. I am pleased to report that these components were found to be performing as intended at the time of the inspection.

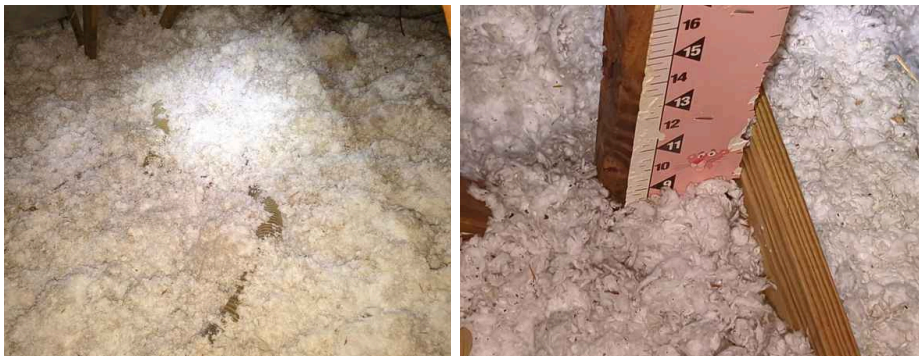
## Insulation: Required Pictures

We attempted to describe the type of insulation observed and the approximate average depth of insulation observed at the unfinished attic floor area or roof structure. Insulation appears adequate, installed between the ceiling rafters. Walking on or disturbing the insulation can affect its energy efficiency. We try to limit this as much as possible during our inspections.

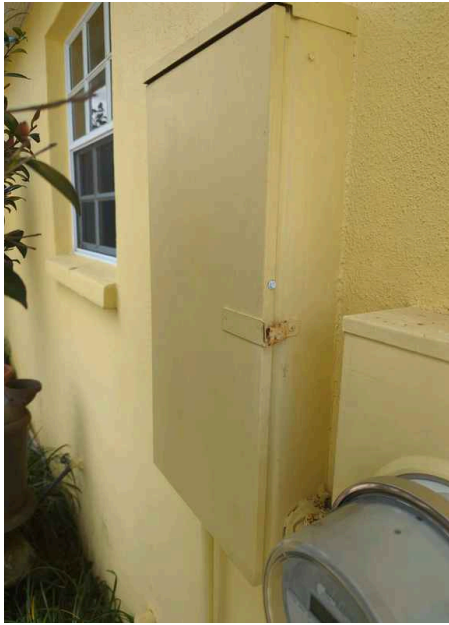
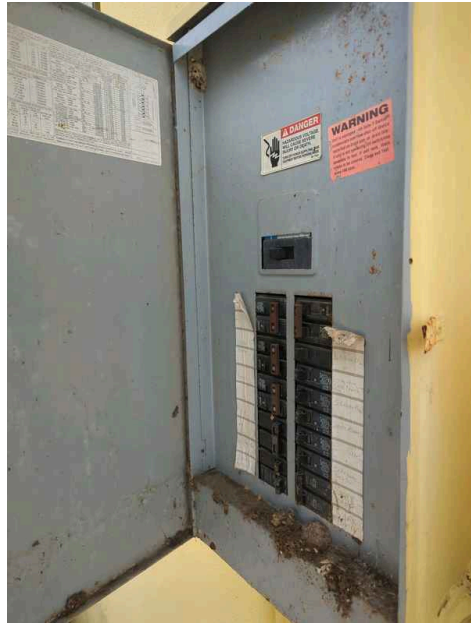
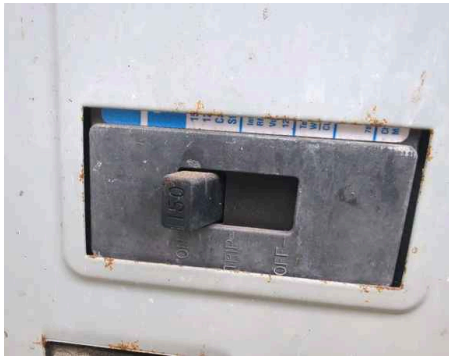
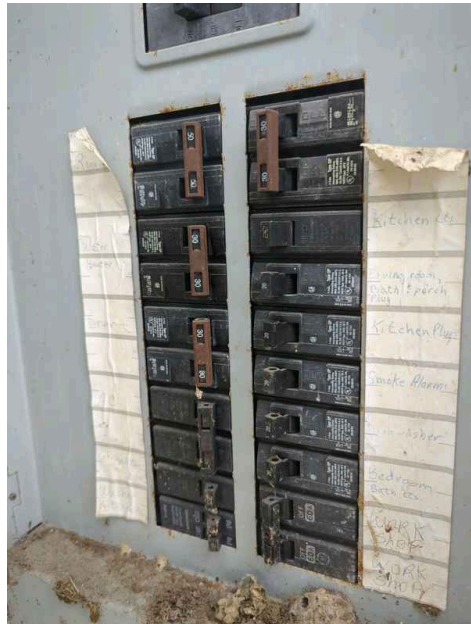
### Main Breaker Panel 2: Required Pictures

The main electrical service entrance and service panel was inspected according to today's InterNACHI Standards of Practice and was performing as intended at the time of the inspection.

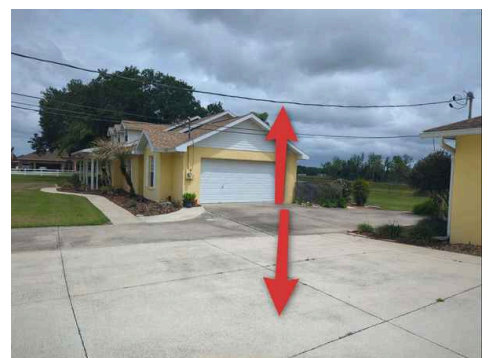
Service cables are positioned too low over the driveway, creating a serious safety concern. The minimum recommended clearance over a driveway is 12 feet. This condition poses a significant risk to anyone using the driveway and must be addressed promptly to prevent potential accidents. It is highly recommended to engage a licensed electrician to reposition the service cables to achieve the necessary clearance, ensuring the safety of the driveway and those who use it.

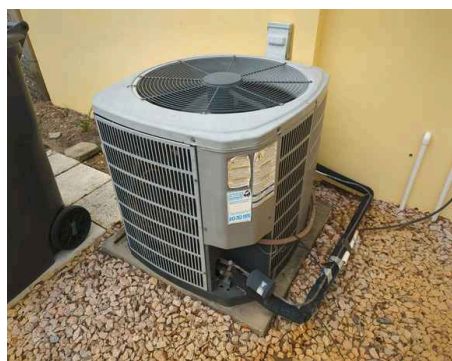
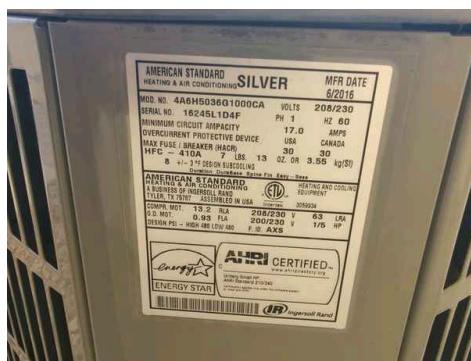
**AC Compressor (Outside Unit): Required Pictures**

The air conditioning system was tested, as outside temperatures were above 65 degrees Fahrenheit at the time of inspection. The compressor equipment was inspected in accordance with current InterNACHI Standards of Practice and applicable local codes and was found to be performing as intended. Testing the AC system in appropriate weather conditions helps ensure accurate performance assessment. Regular servicing by an HVAC professional is recommended to maintain efficiency and prolong system lifespan.

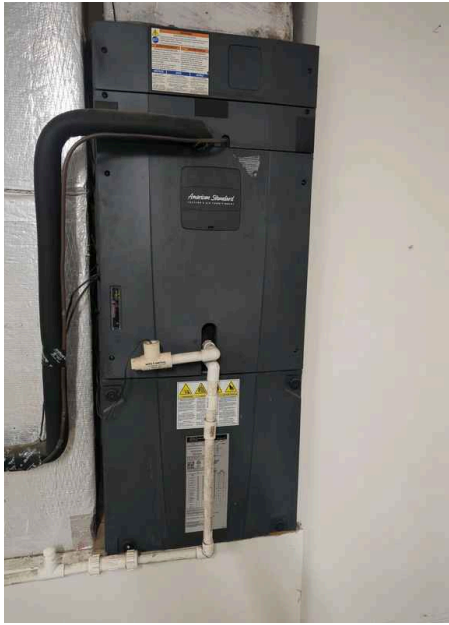
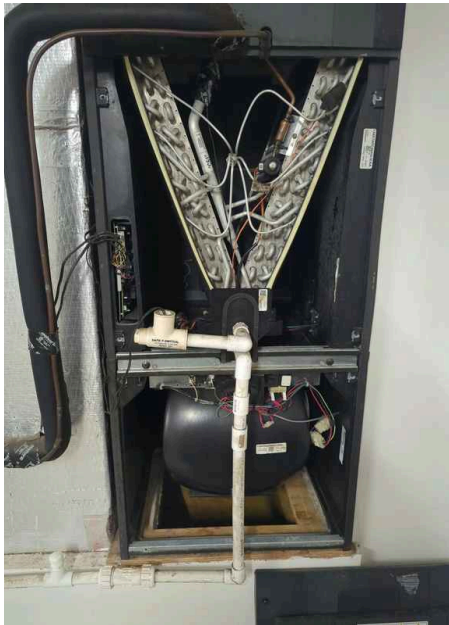
**Furnace/Air Handler (Inside Unit): Required Pictures**

The furnace or air handler is inspected for maintenance, noises, leaks, and proper operation. The furnace or air handler appears to be clean and in good condition. The air handler and heating equipment was inspected according to today's InterNACHI Standards of Practice and or local code and was performing as intended at the time of the inspection. No discrepancies were noted at the time of the inspection.

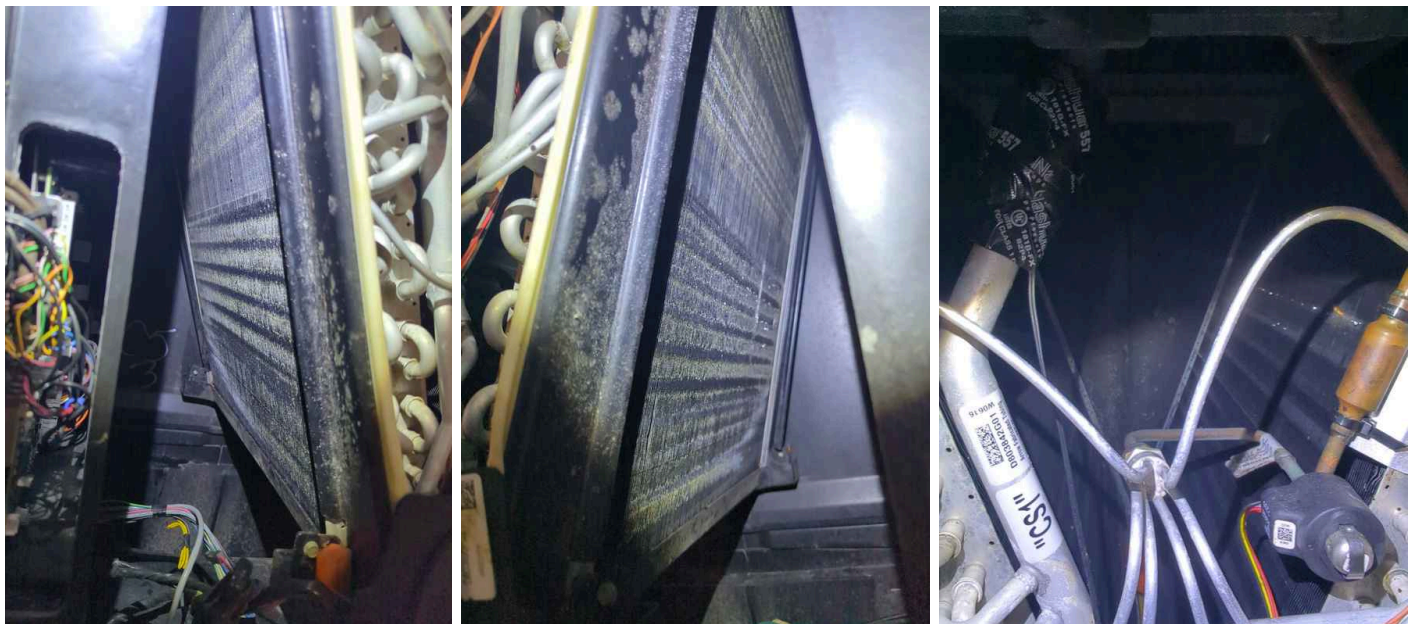
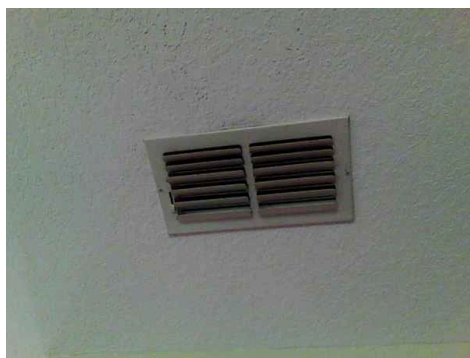
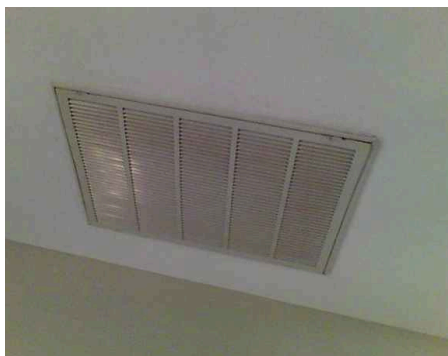
**Evaporator Coil (Inside Unit): Required Pictures**

Yes  
 An overflow device has been installed on the evaporator coil unit. This safety feature is designed to catch and drain condensation if the primary drain line becomes blocked, helping prevent water damage to the interior of the home.

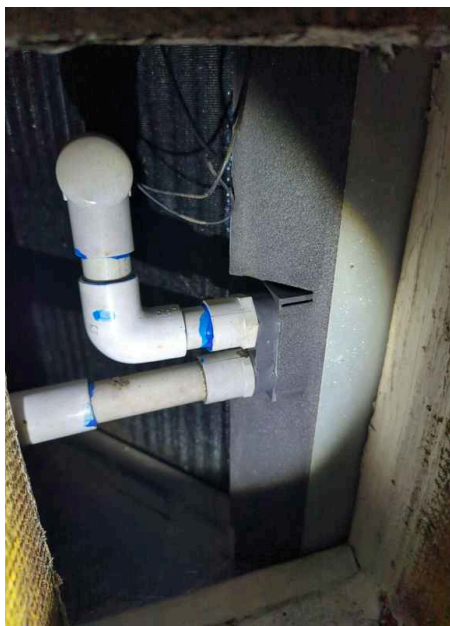
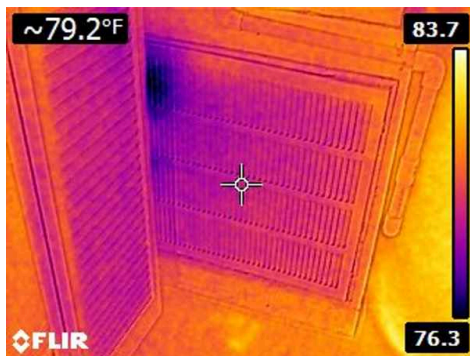
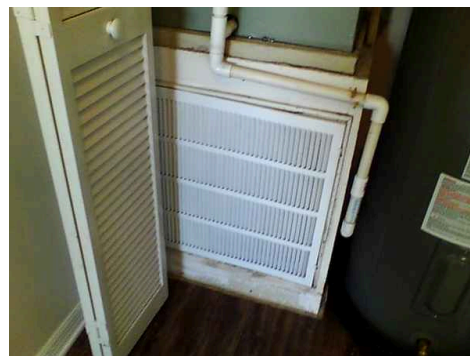
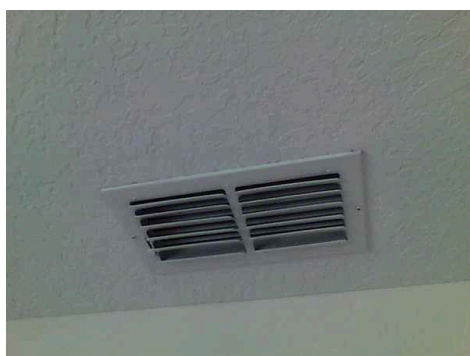
**Evaporator Coil (Inside Unit) 2: Required Pictures**

The evaporator coil was inspected in accordance with current InterNACHI Standards of Practice and applicable local codes. It was found to be performing as intended at the time of inspection. A well-functioning evaporator coil is essential for effective cooling and dehumidification within the HVAC system. Regular maintenance, including cleaning and checking for blockages, is recommended to ensure continued efficiency and prevent potential issues.

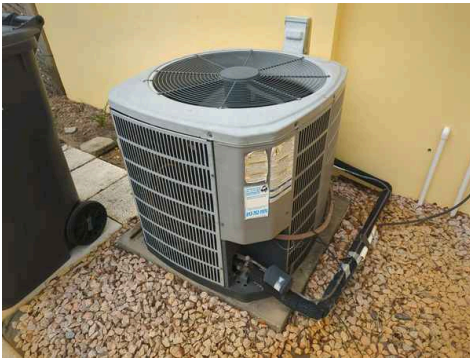
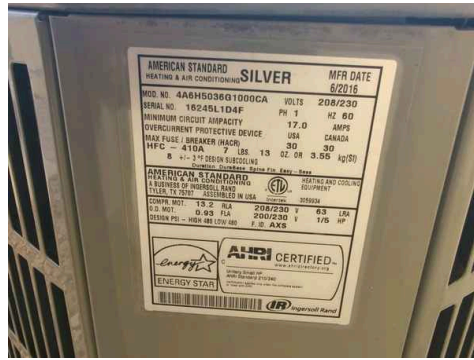
The HVAC equipment is at or near the end of its useful life of 10 to 15 years and should be considered for a replacement with a newer, more efficient system prior to failure. The system was providing cooling at the time of the inspection. However, several repairs and maintenance issues were observed that require evaluation by a licensed HVAC contractor.

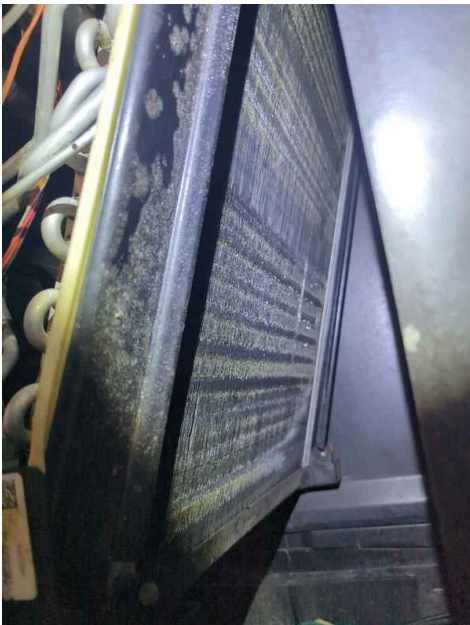
The evaporator coil was observed to be heavily soiled with what appears to be microbial growth. This accumulation can significantly restrict airflow, reduce HVAC efficiency, and potentially contribute to poor indoor air quality, especially for individuals with allergies or respiratory conditions. Prompt cleaning by a licensed HVAC professional is recommended to restore system performance and ensure a healthier indoor environment. Further evaluation is also advised to confirm the nature of the microbial substance and address any underlying moisture issues that may be contributing to its development.

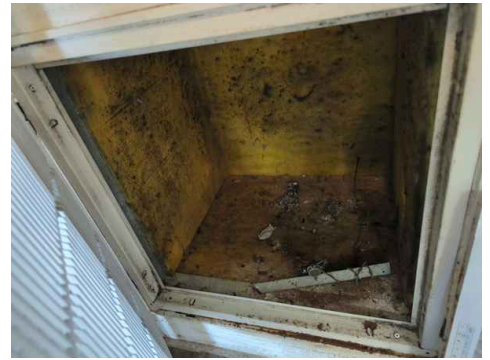
The return air ductwork was observed to have visible dirt and dust accumulation. While this is not uncommon, buildup within the ducts can reduce air quality and system efficiency, particularly affecting individuals with allergies or respiratory sensitivities. It is recommended to have the ductwork professionally cleaned as part of routine HVAC maintenance to support cleaner indoor air and optimal system performance.

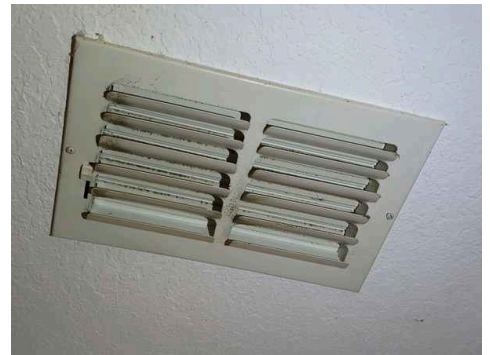
**Ceiling Boot Air Sealing**

**BLACK DIRT/DUST OR MOLD-LIKE SUBSTANCE FROM CEILING VENTS - AIR LEAKAGE**

Black dirt, dust, or a possible mold-like substance was noted coming from one or more ceiling vents. This may be caused by the AC duct boot not being properly sealed to the drywall, allowing air to leak in from the attic. A qualified HVAC professional should inspect the vents and associated ductwork for proper sealing and air leakage. Additionally, mold samples should be taken and sent to a lab for testing. Based on the results, further remediation may be required to address any potential mold issues and ensure the system is operating safely and efficiently. This issue was observed in multiple rooms.

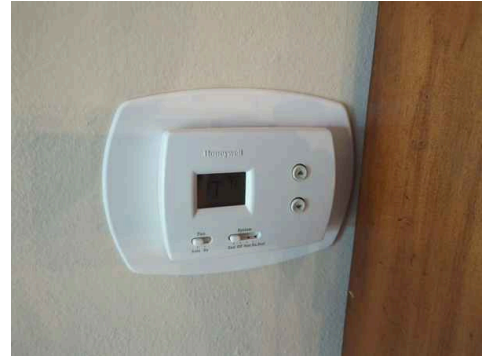
Non-programmable thermostats have no energy saving capabilities as do digital setback-type thermostats. Recommend an upgrade to a modern, digital programmable thermostat. This could yield a saving of up to \$180 per year in energy costs.

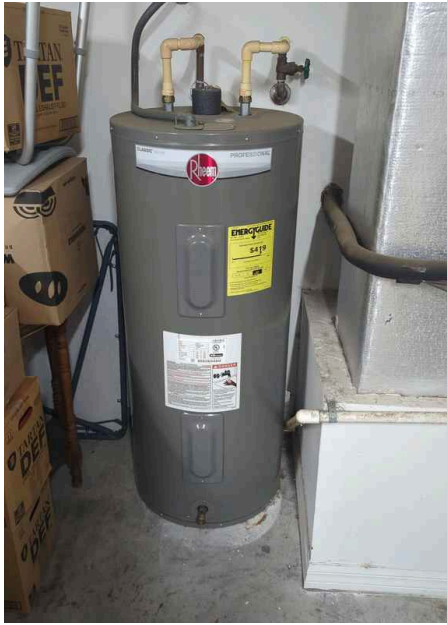
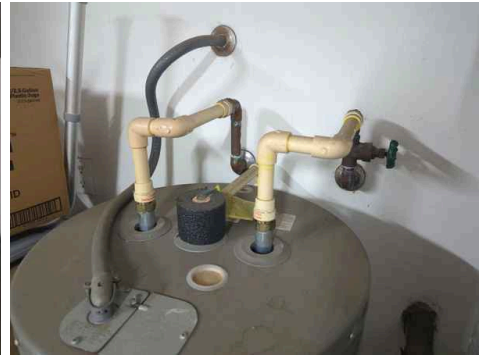
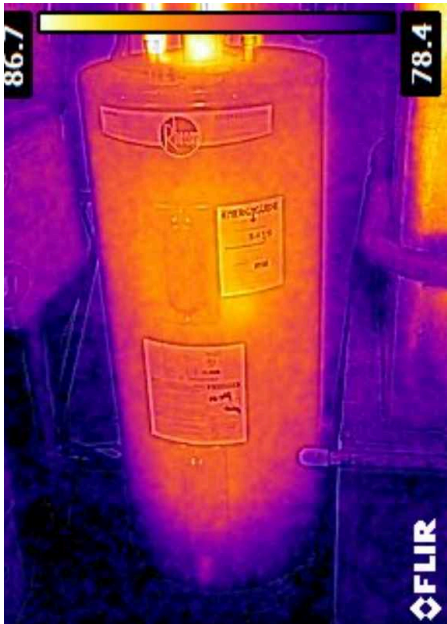
## Water Heater: Required Pictures

The water heater appears to be Satisfactory with no discrepancies observed at the time of the inspection.

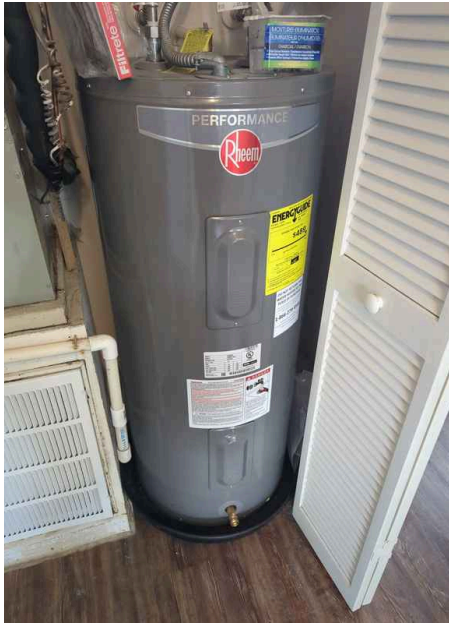
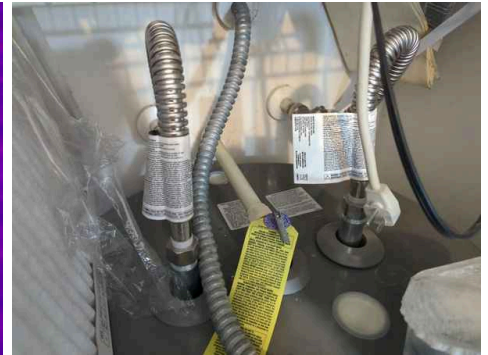
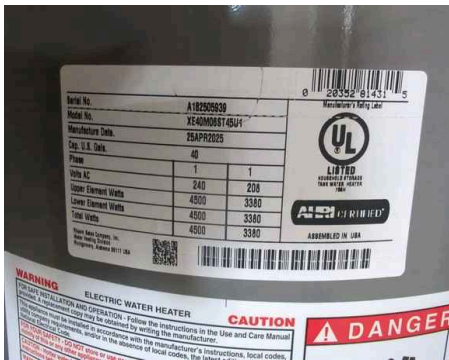
## Water Heater 2: Required Pictures

### Water Heater 2: Condition Satisfactory

The water heater appears to be Satisfactory with no discrepancies observed at the time of the inspection.

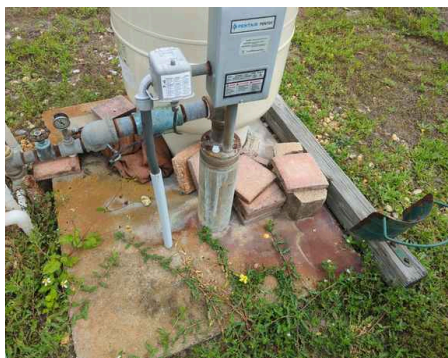
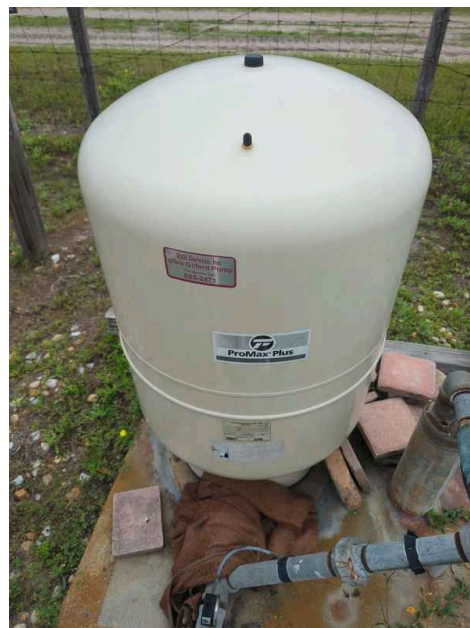
### Well Water Supply: Required Pictures

### Well Water Supply: Condition Satisfactory

The well pump was tested and appeared to be operating normally at the time of the inspection.

The well expansion tank was inspected and appeared to be functioning properly at the time of inspection. No defects or issues were noted, and the tank showed no signs of leaks or pressure irregularities. Regular maintenance is advised to ensure continued reliable performance of the expansion tank.

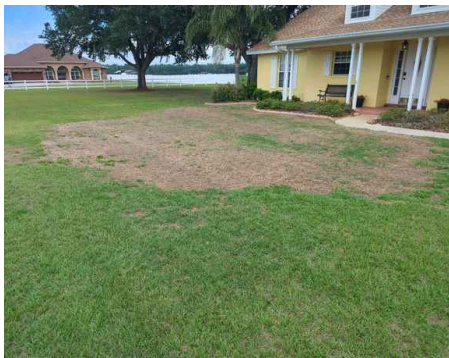
### Septic Waste System: Approximate Location

The inspector made an attempt to identify the approximate location of the waste or septic system.

To ensure the septic system's condition and identify any potential issues, it is highly recommended to have the septic system inspected separately by a licensed plumber or septic system professional. This inspection should be carried out if the sellers have not had it inspected recently or if there are any concerns about the system's performance.

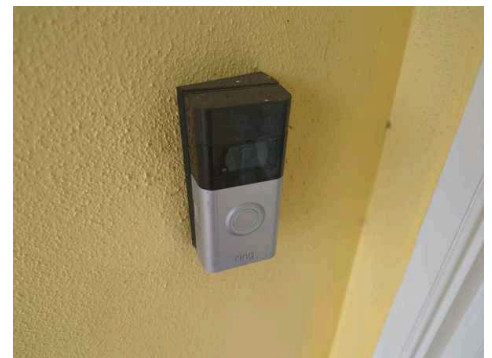
#### **RING DOORBELL - MAY NOT REMAIN WITH THE PROPERTY**

The Ring doorbell installed at the property was tested and found to be operational at the time of the inspection. However, it is important to note that such devices are often considered personal property and may not automatically transfer with the home. Buyers should verify with the seller whether the Ring doorbell is included in the sale and ensure any agreed-upon items are documented in the purchase contract to avoid misunderstandings.

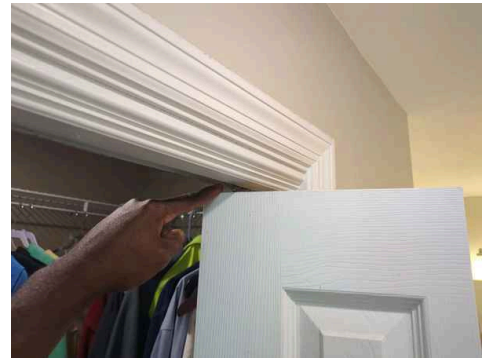
A well-functioning pocket door provides convenience and space-saving benefits, so addressing the sticking issue promptly will help improve the overall usability and aesthetics of the door. Regular maintenance and timely repairs can extend the lifespan of the pocket door and prevent more significant issues in the future.

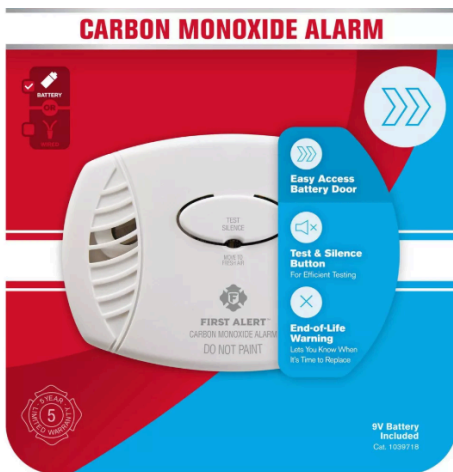
Observed indications of missing carbon monoxide detectors. This poses a significant hazard as carbon monoxide is a dangerous gas that can cause serious health issues or even death. Carbon monoxide detectors should be installed at each level of the home, preferably at lower wall outlets where carbon monoxide would be detected sooner. Refer to the Consumer Product Safety Commission (CPSC) for comprehensive safety information.

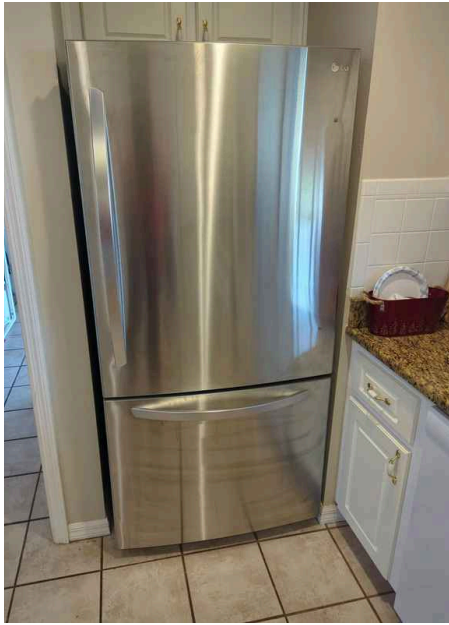
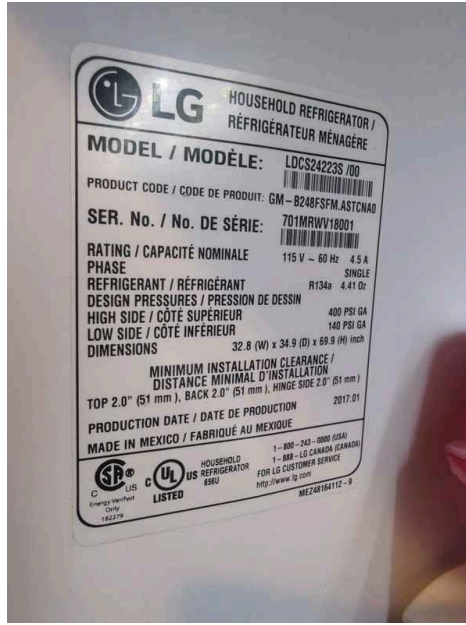
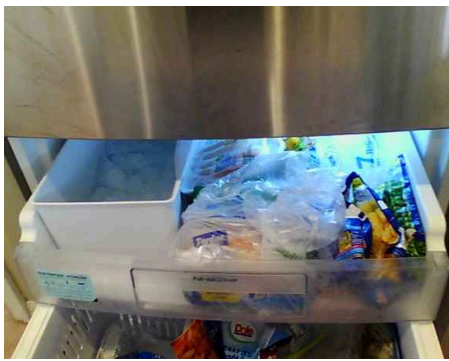
### Refrigerator: Required Pictures

### Refrigerator: Condition Satisfactory

The refrigerator was operating when checked at the time of the inspection. If present the ice maker was working, and the refrigerator was cooling. This indicates that the unit is functioning properly and effectively maintaining the desired temperature. Recommend regular maintenance and periodic inspections by a qualified appliance technician to ensure the refrigerator continues to operate efficiently and reliably.

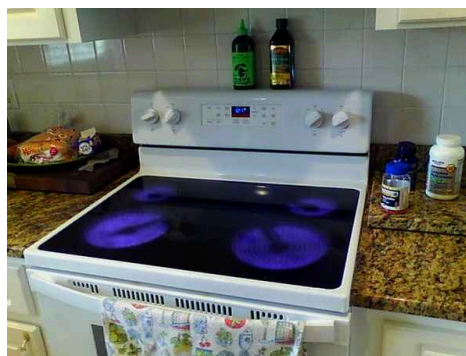
### Cook top/Range: Required Pictures

### Cook top/Range: Condition Satisfactory

The range, burners, heating elements and dial knobs were inspected according to today's InterNACHI Standards of Practice and or local building code and was performing as intended at the time of the inspection.

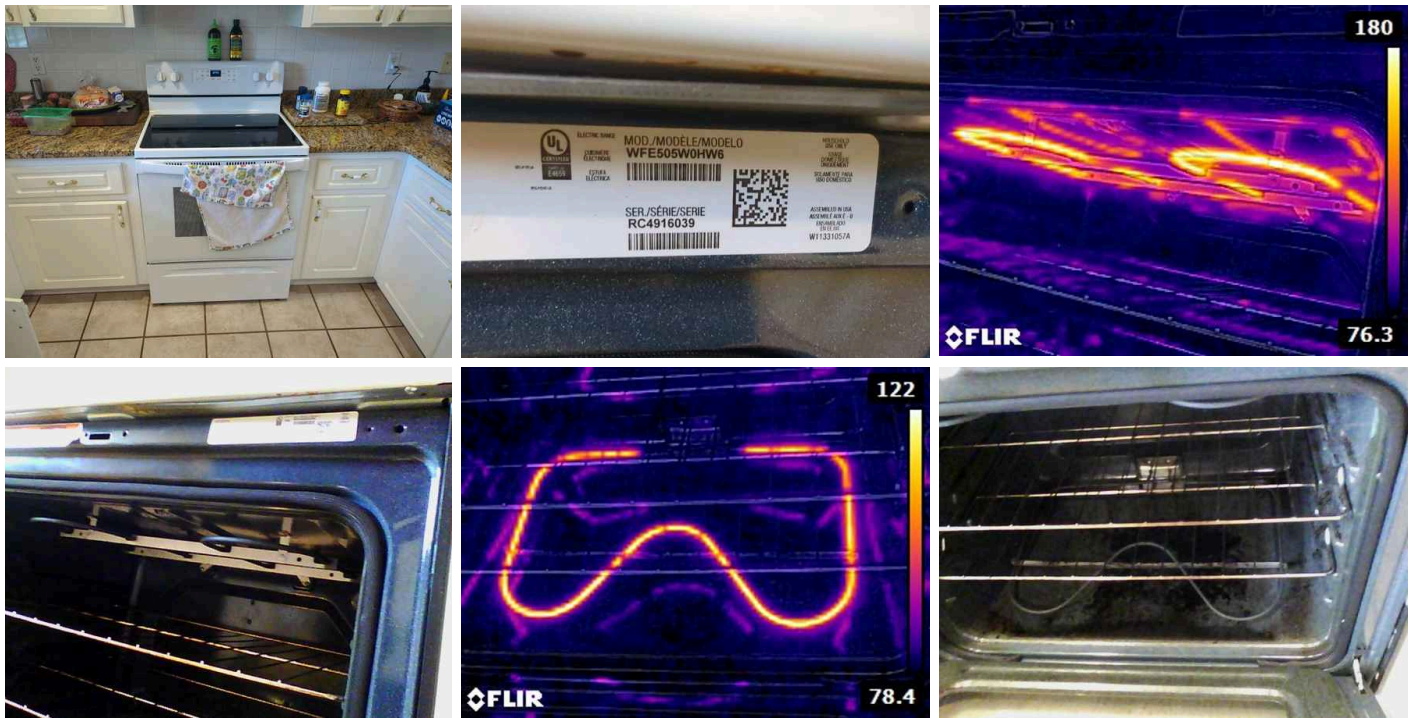
## Oven: Required Pictures

## Oven: Condition Satisfactory

The oven was inspected in accordance with InterNACHI Standards of Practice and local building codes. Both the upper and lower electric oven elements were tested and found to be performing as intended at the time of inspection. It is important to note that while the components were functional during the evaluation, they can fail unexpectedly. Regular maintenance and monitoring are recommended to ensure continued performance and safety.

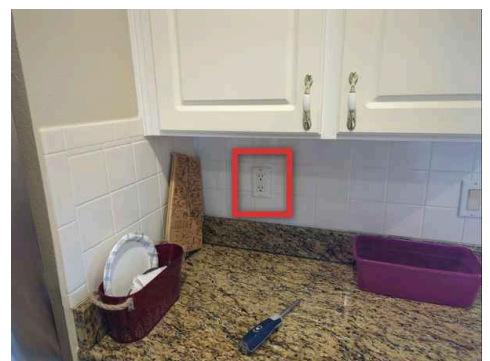
Observed that one or more GFCI outlets in the kitchen were faulty. Faulty GFCI outlets can fail to provide the necessary protection against electrical shock, especially in areas prone to moisture. A licensed electrician should be consulted to evaluate and repair or replace the faulty GFCI outlets as necessary to ensure safety and proper functionality.

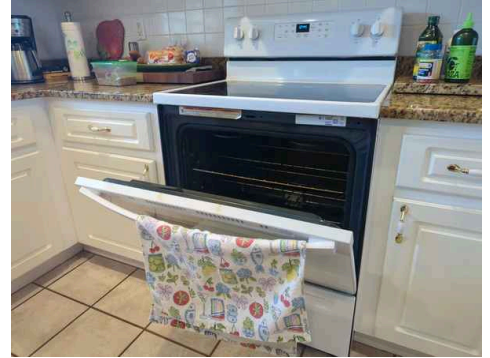
A free-standing oven anti-tip bracket or device was not observed/installed during the inspection. This absence poses a safety concern, particularly for households with small children. To mitigate this risk and enhance safety, it is strongly recommended to install an anti-tip bracket for the free-standing oven. This safety device helps secure the appliance in place, preventing accidental tipping or toppling, which can lead to serious injuries. Installing the anti-tip bracket is a proactive measure that ensures the safety of all occupants, especially children, in the household.

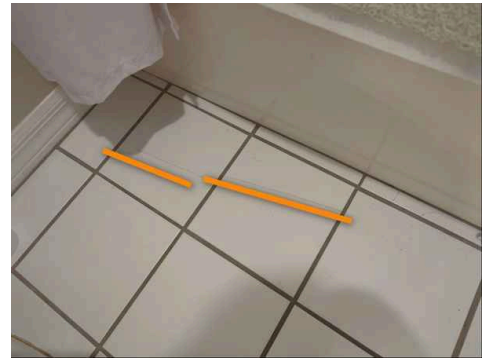
While conducting the inspection, I noticed the presence of cracked tiles in one or more of the bathrooms. This issue, while not uncommon, may affect the overall appearance and safety of the space. To improve the situation, I suggest considering the replacement of the cracked tiles.

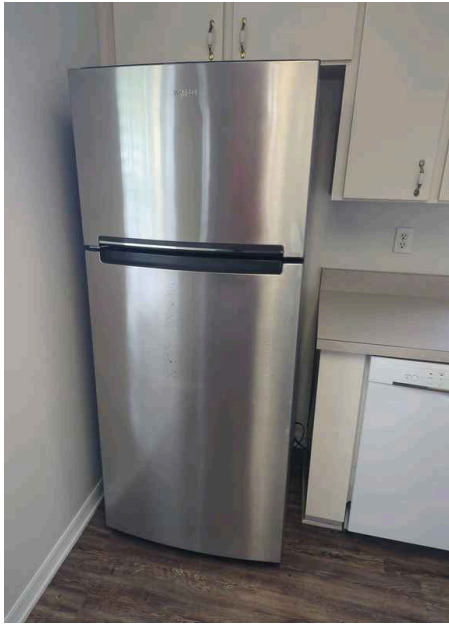
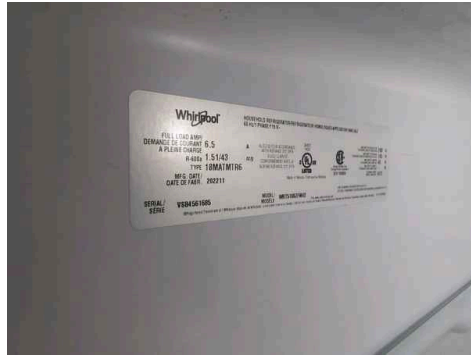
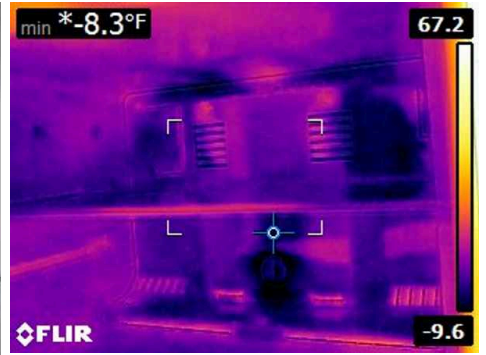
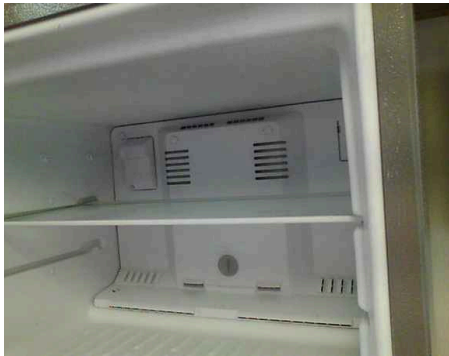
### Refrigerator: Required Pictures

### Refrigerator: Condition Satisfactory

The refrigerator was operating when checked at the time of the inspection. If present the ice maker was working, and the refrigerator was cooling. This indicates that the unit is functioning properly and effectively maintaining the desired temperature. Recommend regular maintenance and periodic inspections by a qualified appliance technician to ensure the refrigerator continues to operate efficiently and reliably.

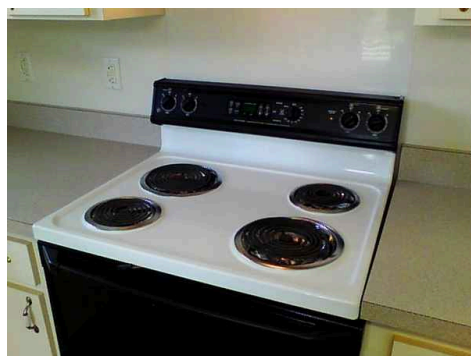
### Cook top/Range: Required Pictures

### Cook top/Range: Condition Satisfactory

The range, burners, heating elements and dial knobs were inspected according to today's InterNACHI Standards of Practice and or local building code and was performing as intended at the time of the inspection.

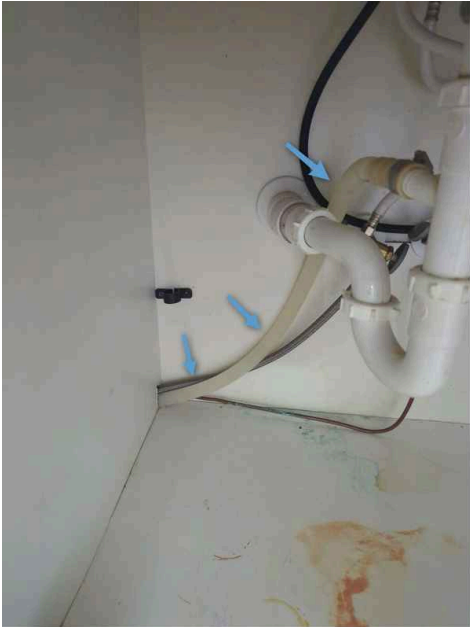
A visible anti-siphon loop or backflow prevention device was not installed at the dishwasher drain line. Some newer dishwashers may have built-in antisiphon devices that are not visible. The buyer is encouraged to consult the owner's manual or contact the manufacturer if an anti-siphon device is not visible. The lack of an anti-siphon device in a dishwasher is a SAFETY HAZARD.

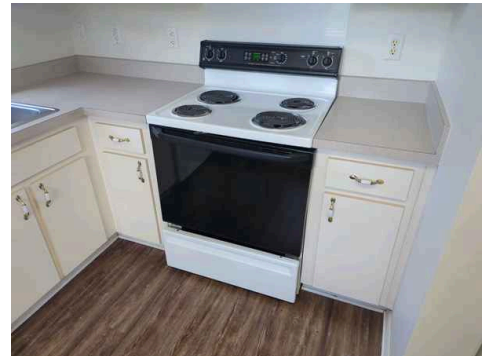
#### **NO ANTI-TIP**

A free-standing oven anti-tip bracket or device was not observed/installed during the inspection. This absence poses a safety concern, particularly for households with small children. To mitigate this risk and enhance safety, it is strongly recommended to install an anti-tip bracket for the free-standing oven. This safety device helps secure the appliance in place, preventing accidental tipping or toppling, which can lead to serious injuries. Installing the anti-tip bracket is a proactive measure that ensures the safety of all occupants, especially children, in the household.

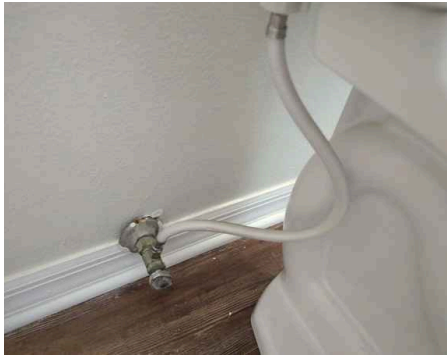
### Toilets: Toilet Cut-Off Valves: Present and Functional

Toilet cut-off valves were observed and tested during the inspection. They were found to be present and functional, allowing for proper water shut-off if needed. Regular testing and occasional cleaning are recommended to ensure continued reliability.

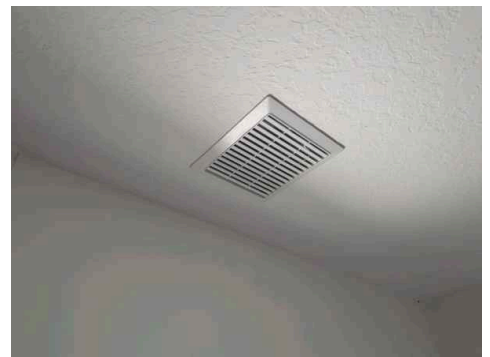
It was observed that one or more bathroom exhaust fans are inoperable. An inoperable fan is a conducive condition for mold growth. A qualified electrician or HVAC professional should be consulted to repair or replace the affected exhaust fans to ensure proper ventilation, prevent mold growth, and maintain indoor air quality.
