SAFELINE HOME INSPECTIONS LLC

## PRE-DRYWALL INSPECTION COPY

1234 Main Street  
Brandon, FL 33511

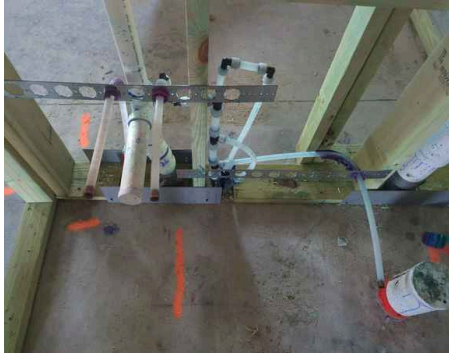
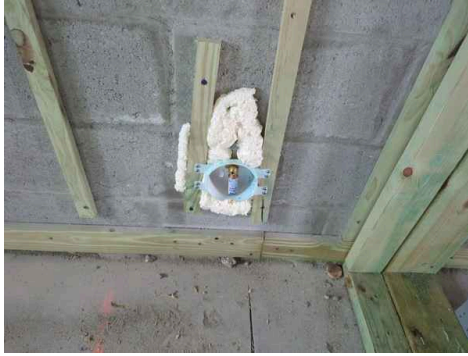
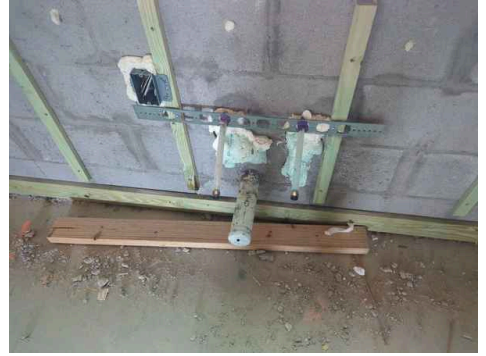
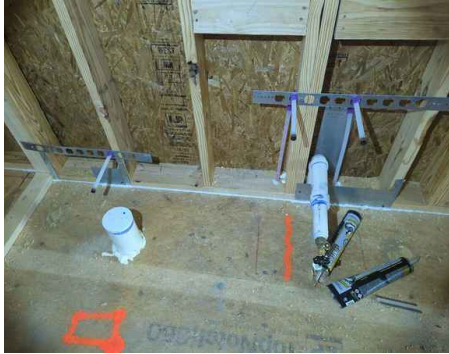
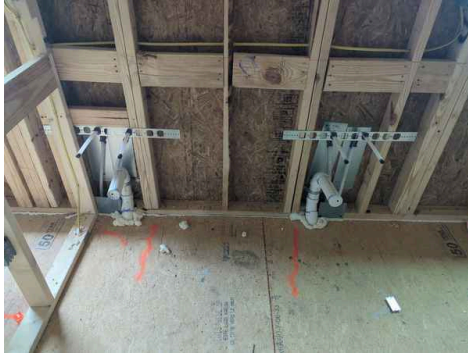
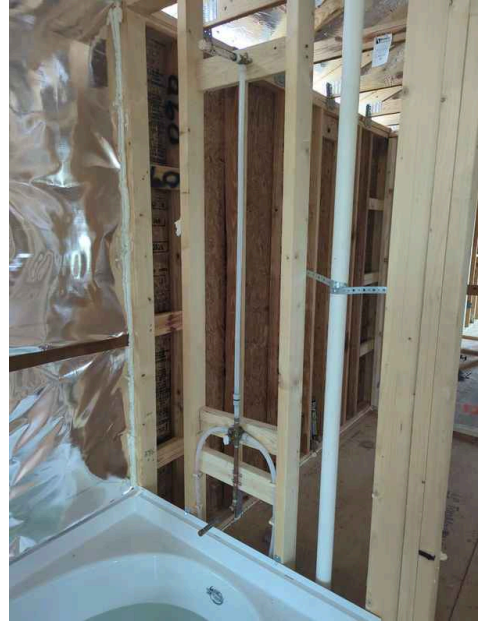
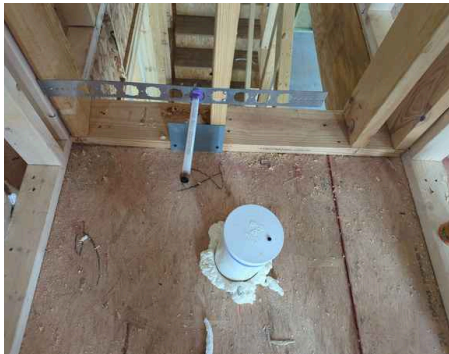
## All Stub Outs Secure: Plumbing Stub-Outs - Secure

All accessible plumbing stub-outs were inspected and found to be secure.

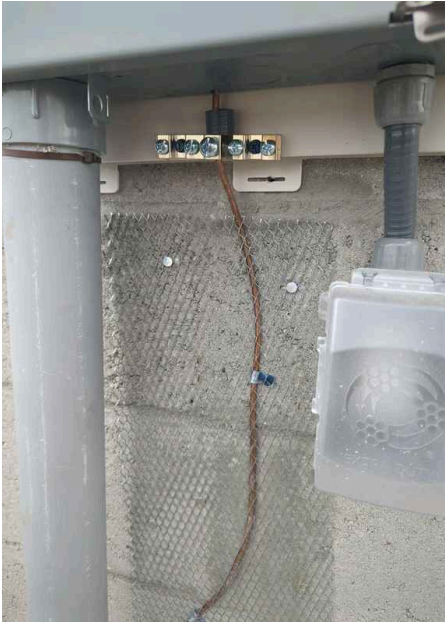
## Grounding/Bonding Wire Properly Secured: Visual Inspection

Only the visible areas were inspected at the time of inspection. No deficiencies noted to visible areas unless otherwise noted below.

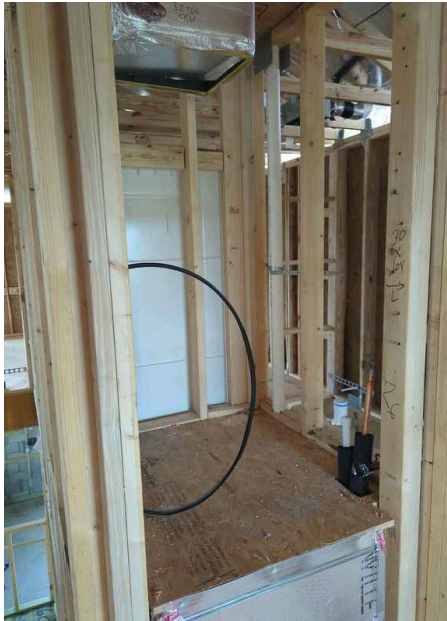
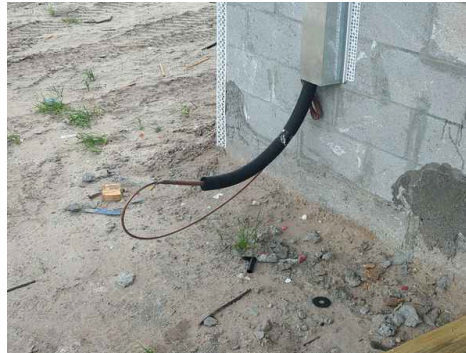
### Central air location

Rear of the Home, Upstairs Hallway

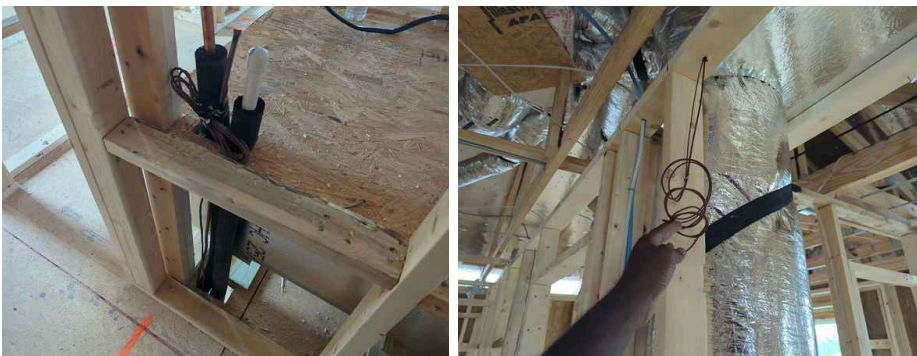
## Refrigerant Drain Line: Pictures

Thermostat wire upstairs hallway
